# THE PENTAGON BUILDING PERFORMANCE REPORT

January 2003

Following the September 11 crash at the Pentagon of an airliner commandeered by terrorists, the American Society of Civil Engineers established a building performance study team to examine the damaged structure and make recommendations for the future. The members of the team reviewed available information on the structure and the crash loading and drew on focused assessments by others. In addition to analyzing the essential features of column response to impact, they investigated the residual frame capacity and the structural response to the fire. Plausible mechanisms for the response of the structure to the crash were established. Recommendations are offered for future design and construction along with suggestions for research and development.

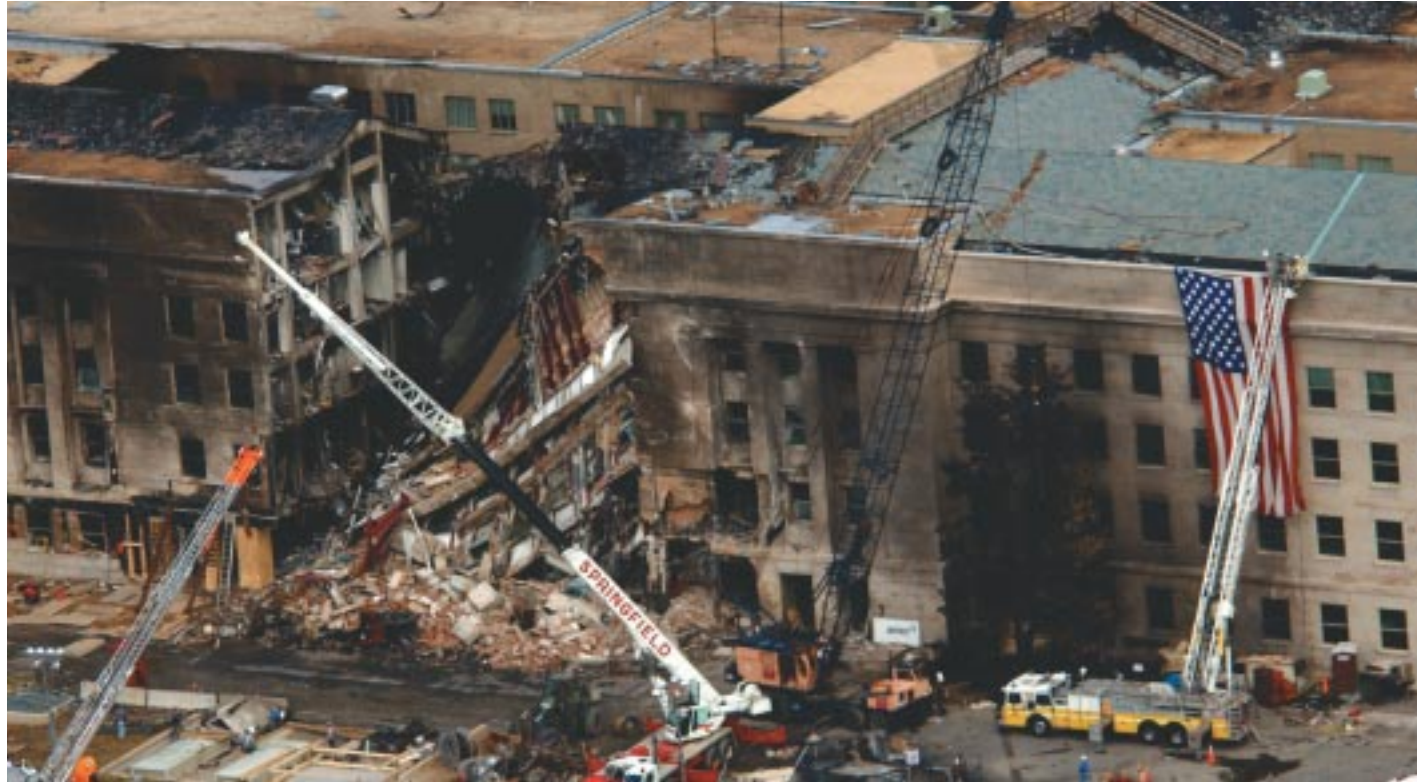
Figure 1.3 Crash damage

Figure 1.3 presents an exterior view of the extent of damage from the crash, including a collapsed portion of Ring E at the point of impact, beyond which the impact destruction from the decelerating aircraft continues; the subsequent devastation from the fire is also evident. The superior performance of the improved window system incorporated during the renovation is evident on the right.

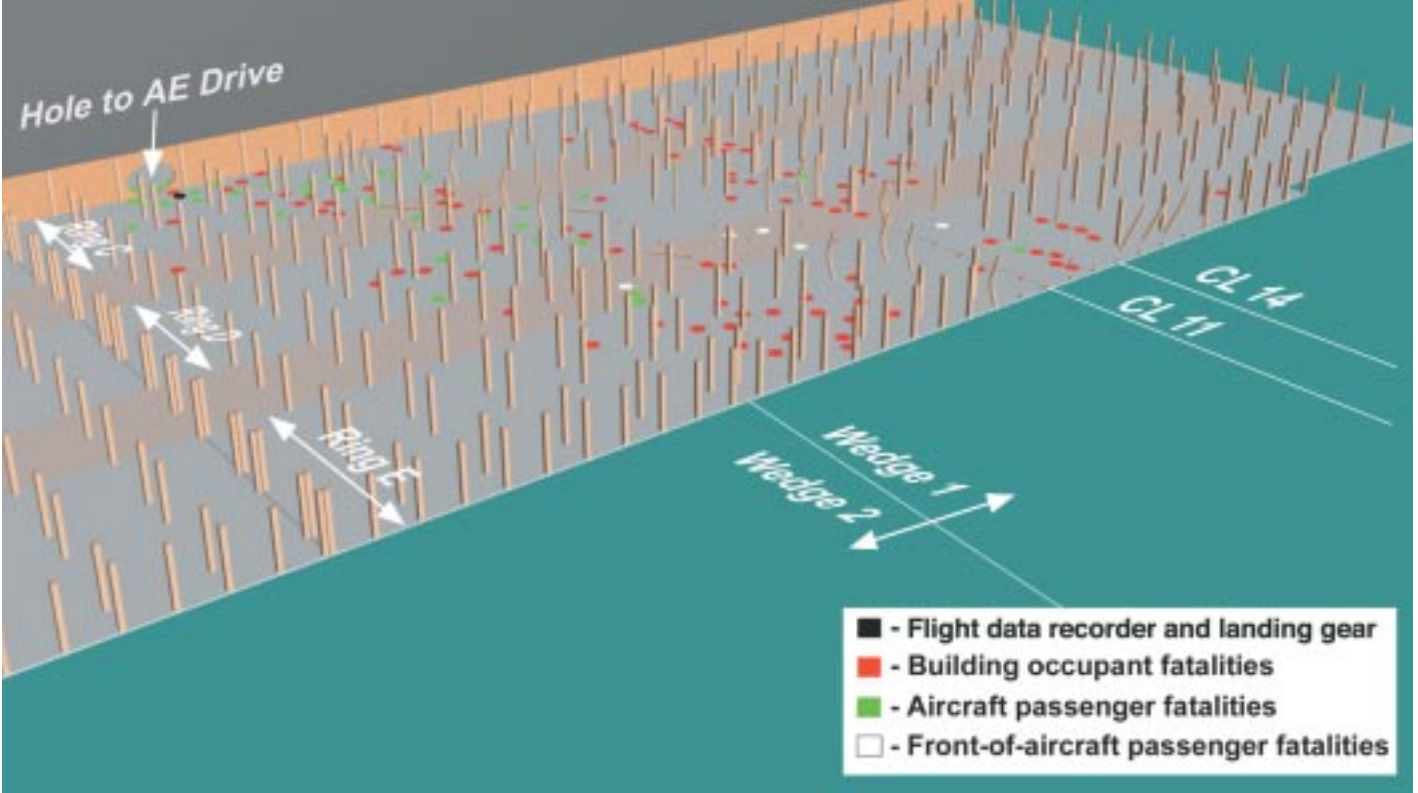
Figure 3.17 Fatalities found in first story

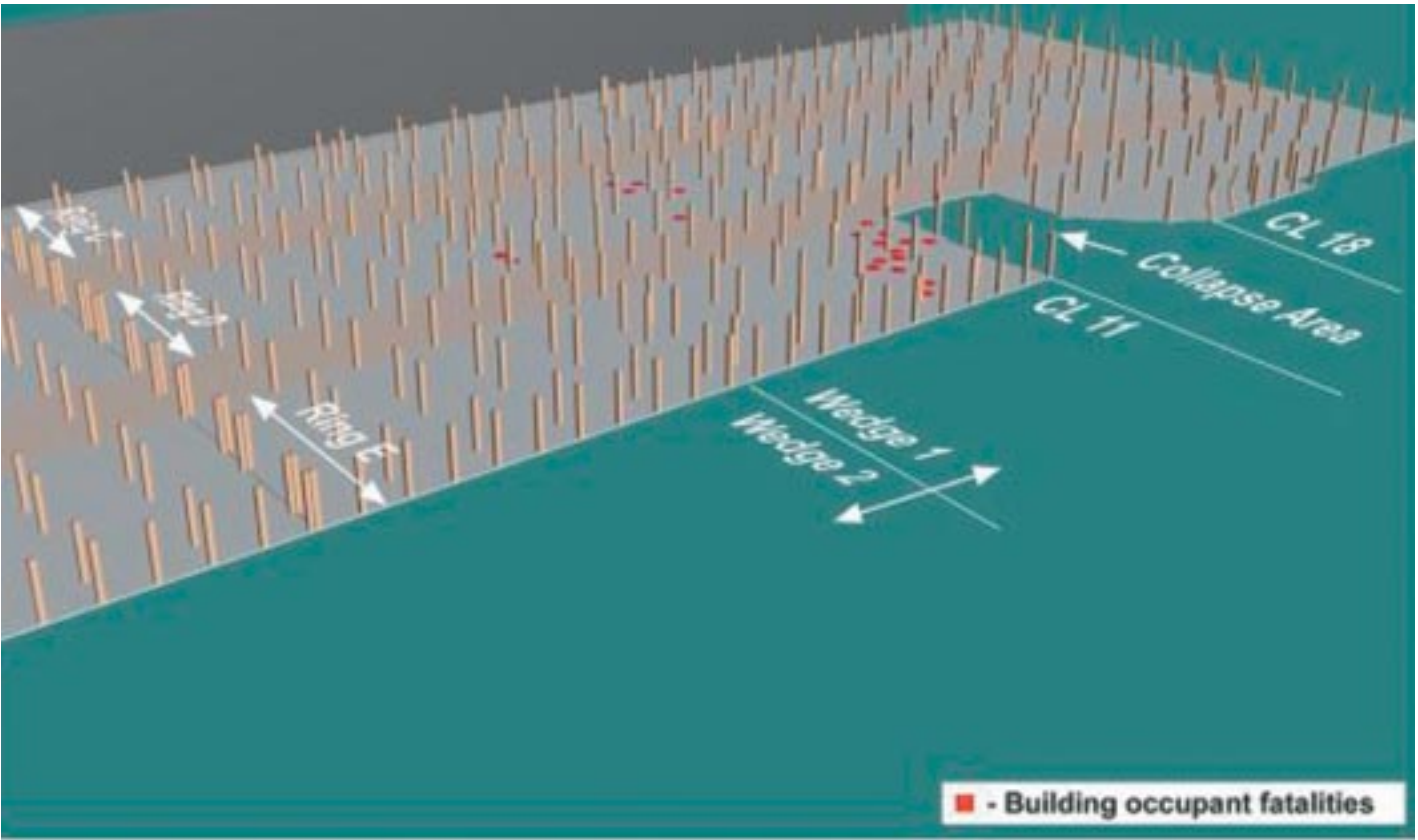
Figure 3.18 Fatalities found in second story

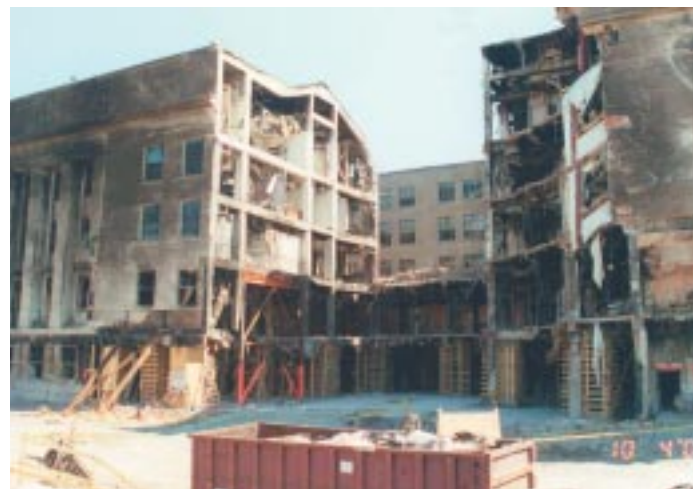
By the time the full Pentagon BPS team visited the site, all debris from the aircraft and structural collapse had been removed (figure 5.1) and shoring was in place wherever there was severe structural damage. The design team charged with reconstructing the Pentagon was assessing the building and preparations were being made to demolish the areas for reconstruction. Consequently, the Pentagon BPS team never had direct access to the structural debris as it existed immediately after the aircraft impact and subsequent fire.

Figure 5.1 Impact area with debris removed

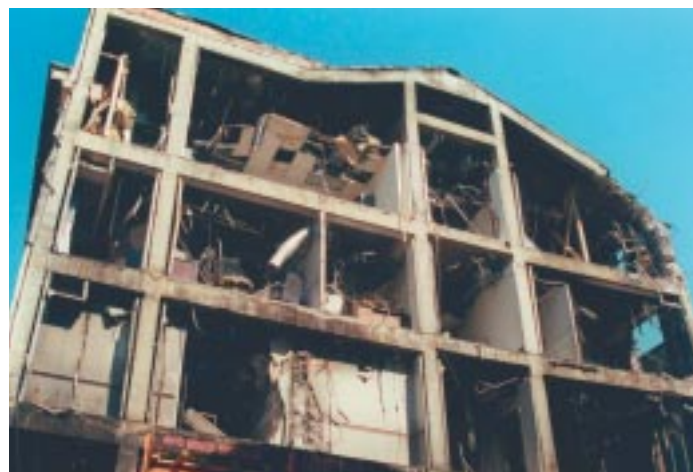
The collapsed portion of Ring E was immediately south of an expansion joint on column line 11 (figures 5.2 and 5.3). The collapsed area extended south from the expansion joint to approxi-

Figure 5.2 Beams and columns on north side of expansion joint

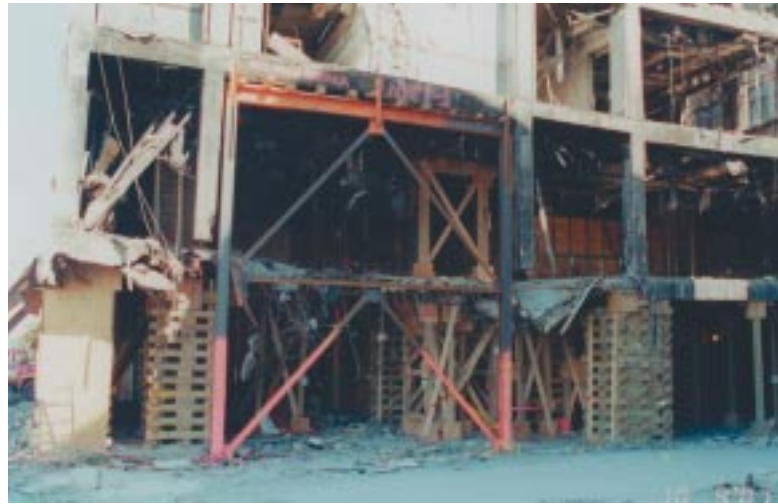
Figure 5.5 Missing first-floor columns 11A, 11B, and 11C

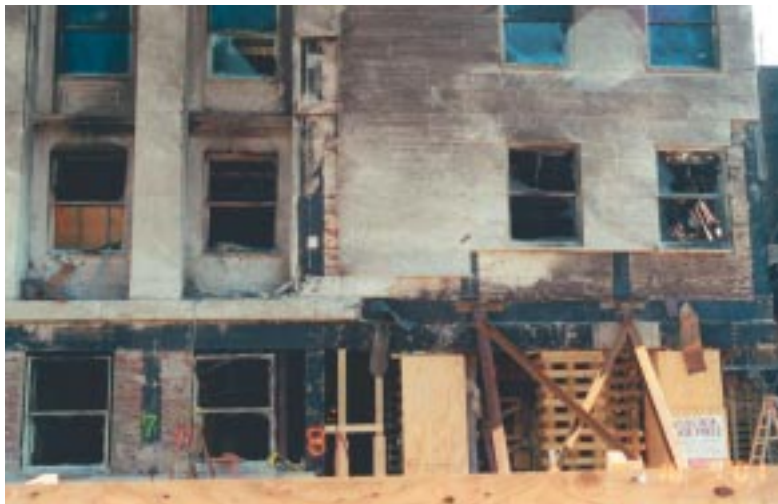
Figure 5.6 Facade damage to the north of the impact area

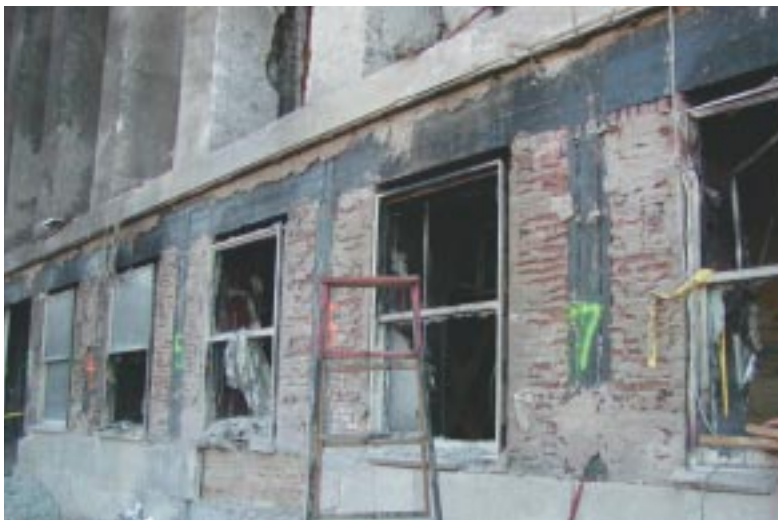
Figure 5.7 First-floor facade damage to the north of the impact area

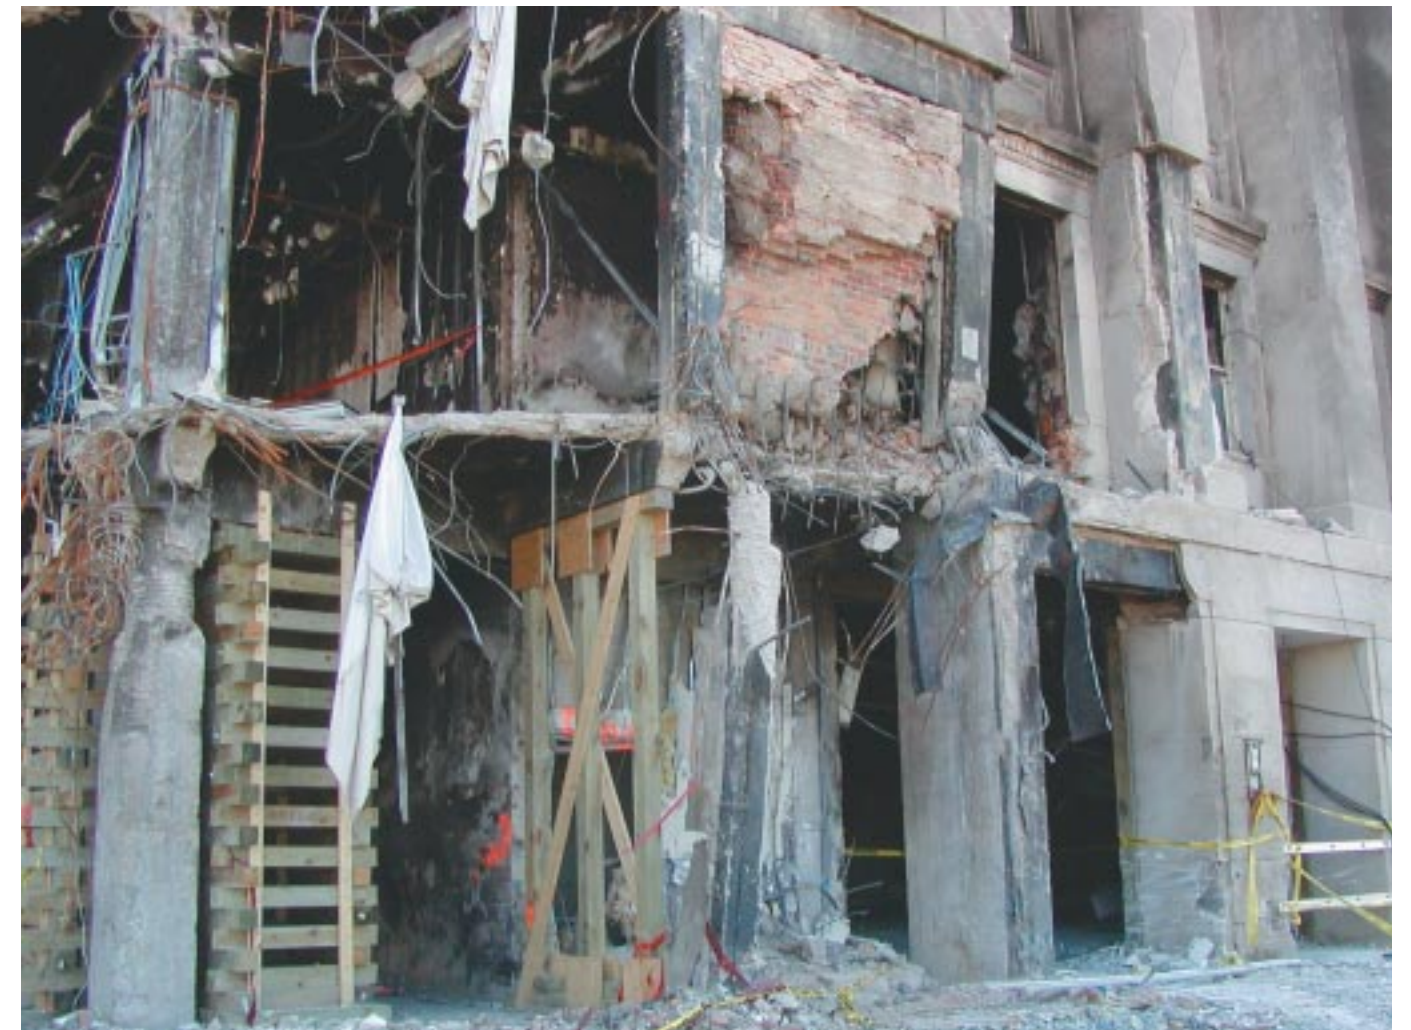
Figure 5.8 Facade damage to the south of the impact area

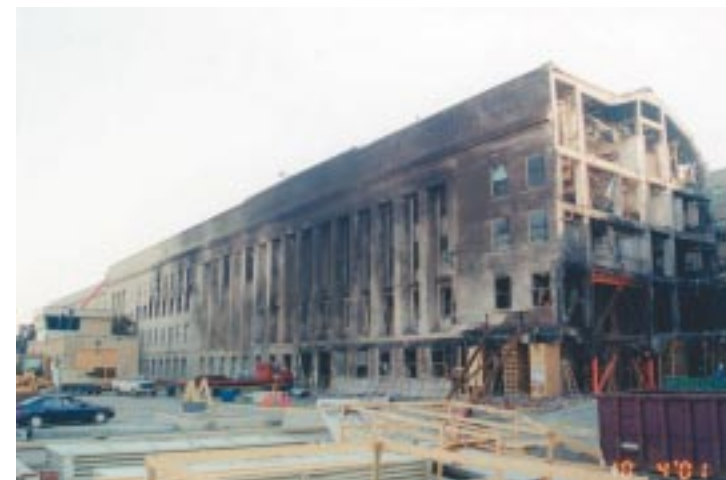
Figure 5.9 Exterior evidence of fire to the north of the impact area

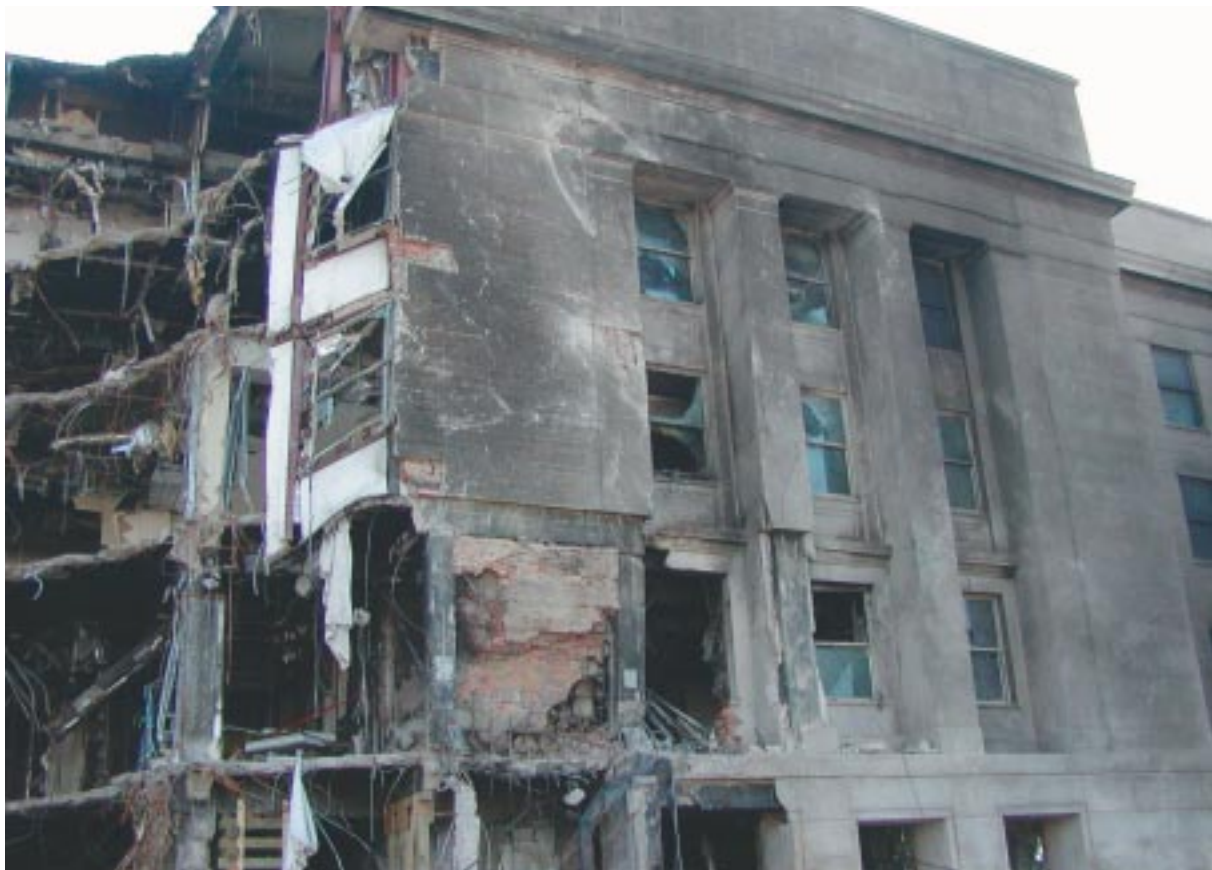
The west facade of the Pentagon was severely scarred by debris impact, particularly to the south of the collapse area (figure 5.11). Just above the second-floor slab, the exterior columns on column lines 18 and 19

Figure 5.11 Debris scars at upper levels south of impact area

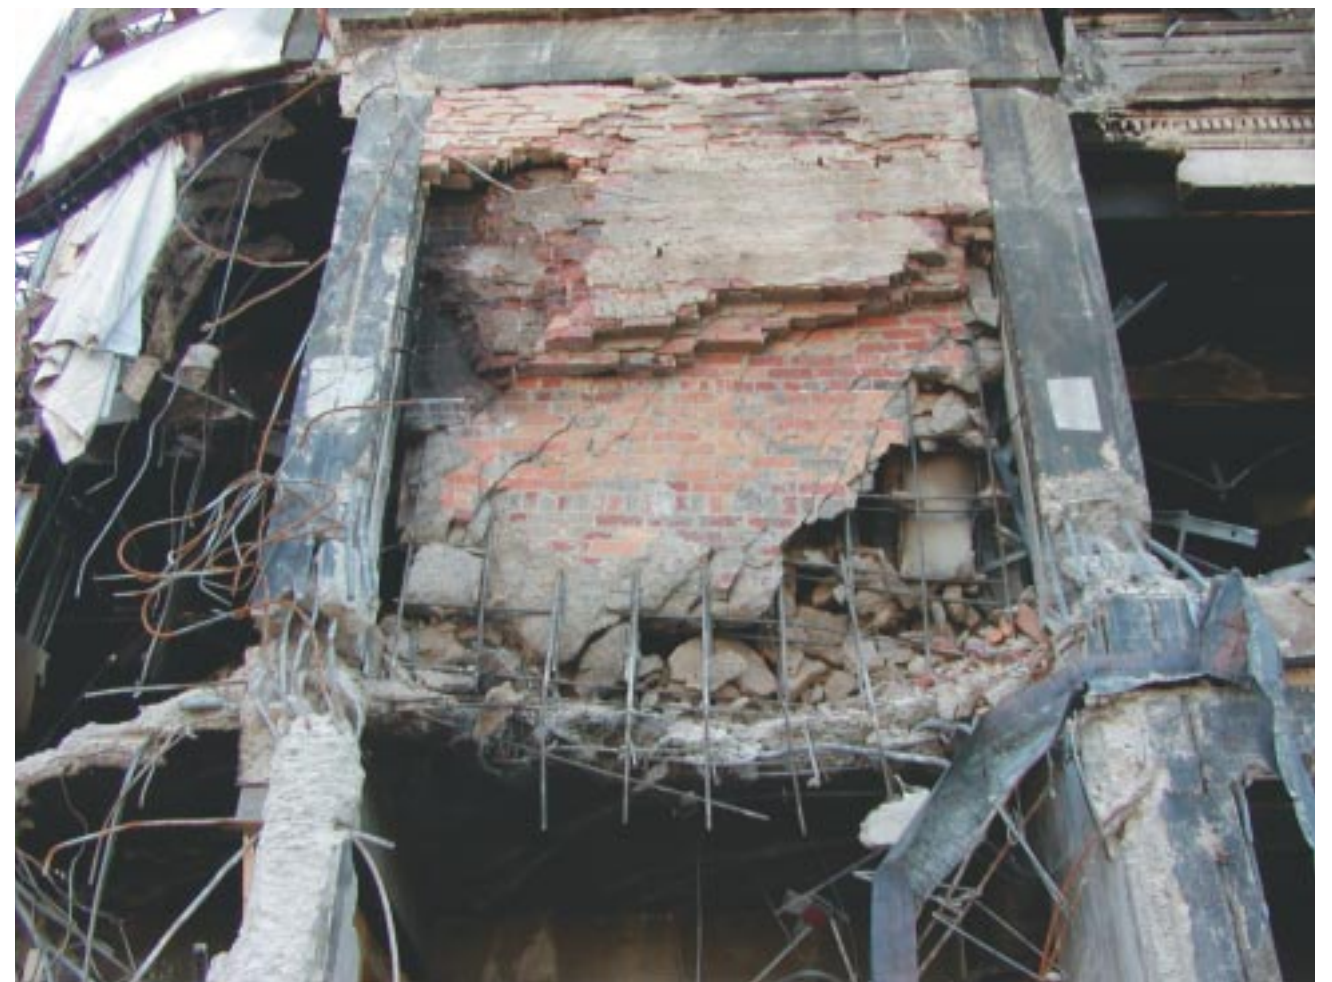
Figure 5.12 Gashes from impact of right wing

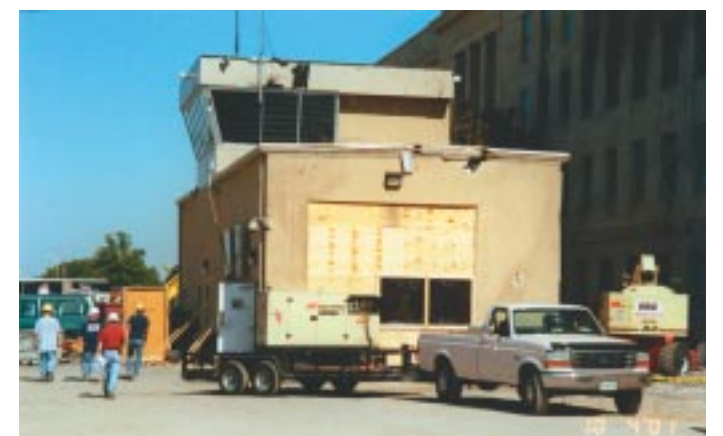
Figure 5.13 Damage to fire station

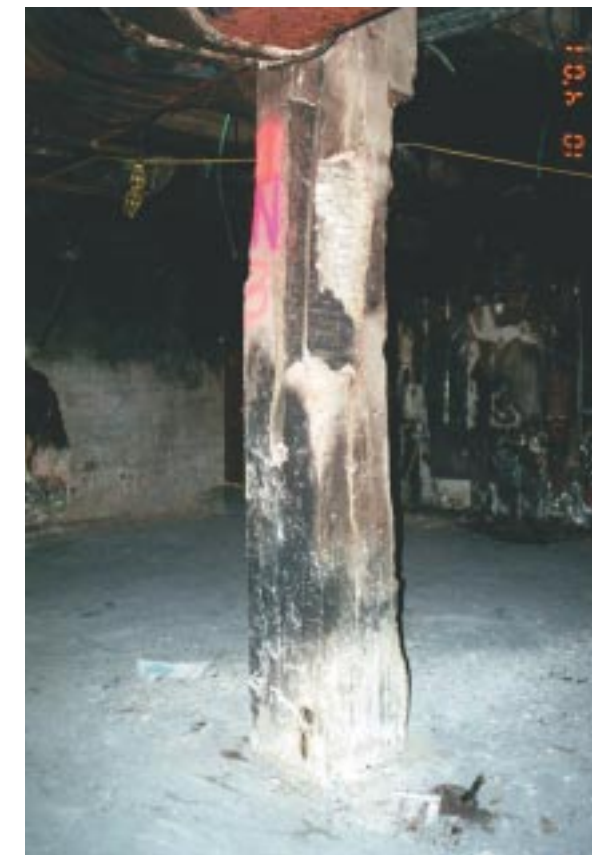
Figure 5.19 Column 3N damaged by impact and fire

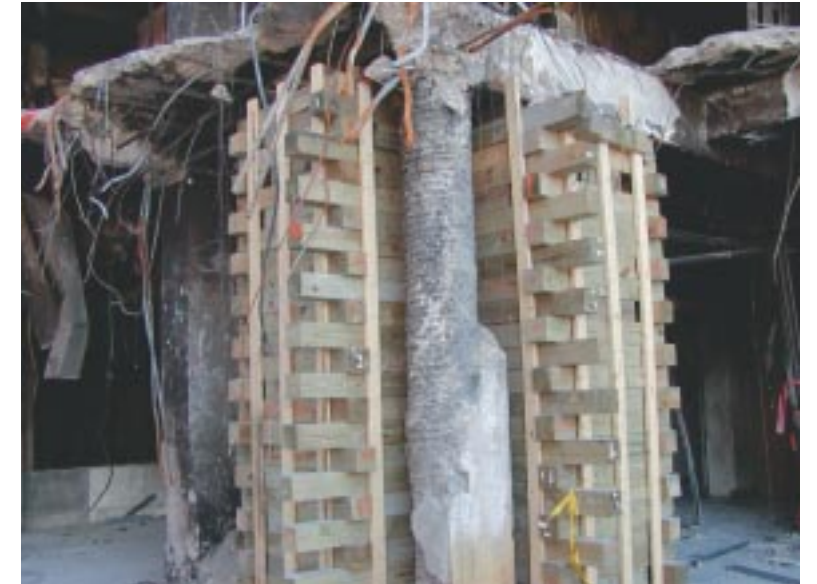
Figure 5.18 Column 15B with concrete cover removed by impact

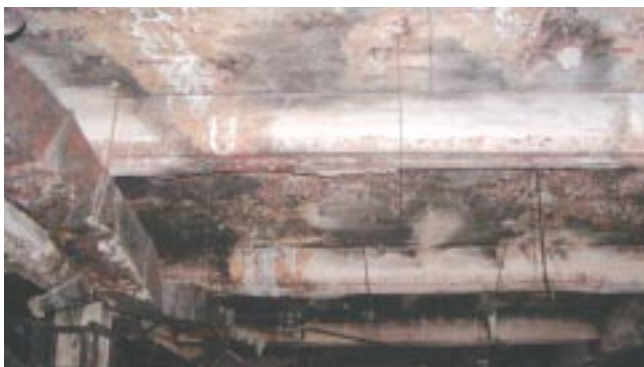
Figure 5.25 Impact and fire damage near column line C

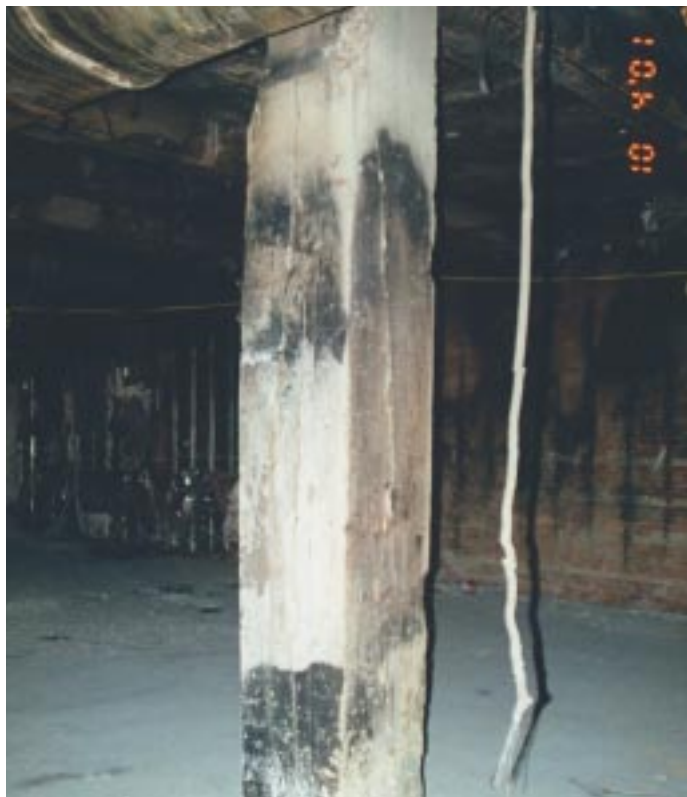
Figure 5.24 Cracked column 5N

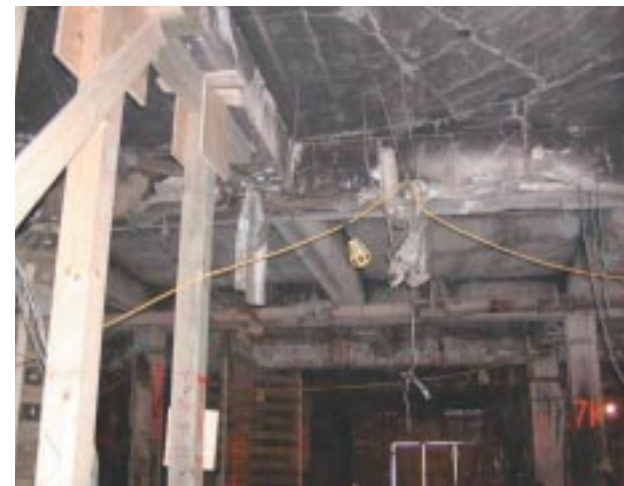
Figure 5.26 Impact damage near column 6K

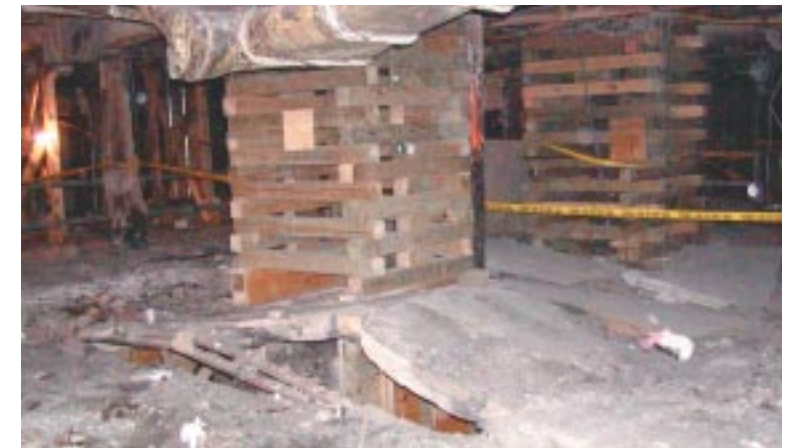
Figure 5.27 Breached second-floor slab

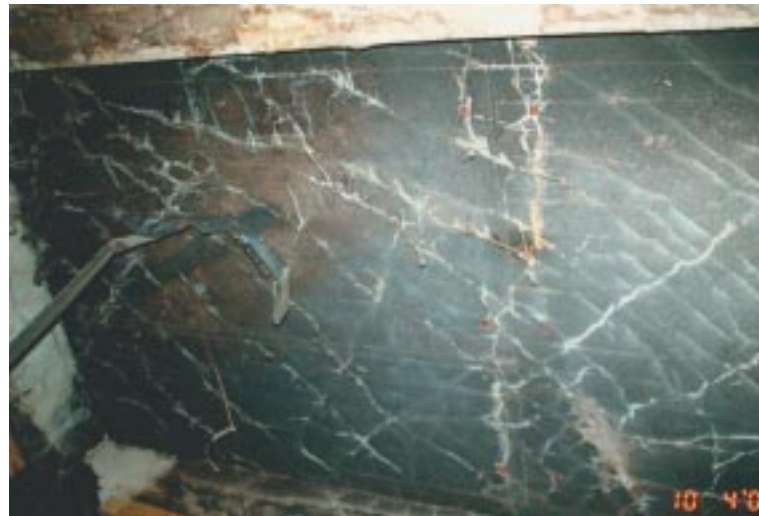
Figure 5.28 Crack patterns in second-floor slab

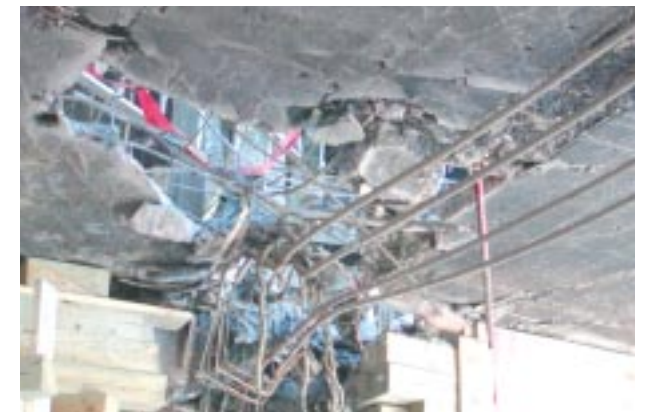
Figure 5.29 Concrete stripped from floor beam

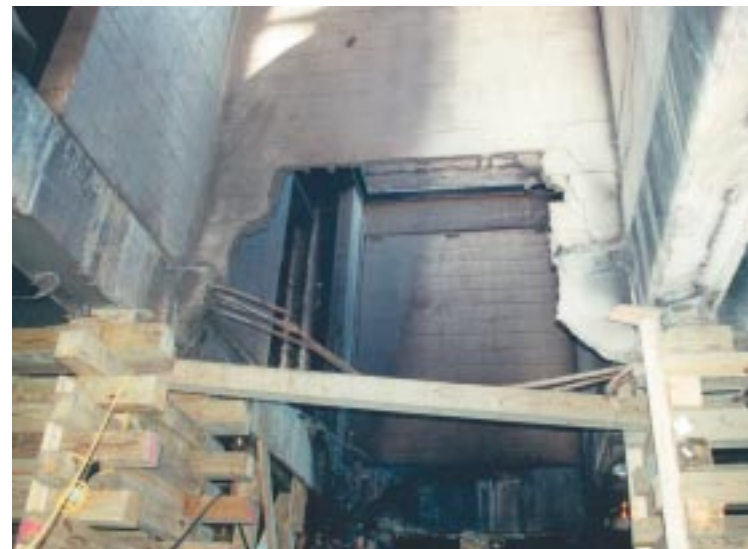
Figure 5.30 Missing beam in air shaft

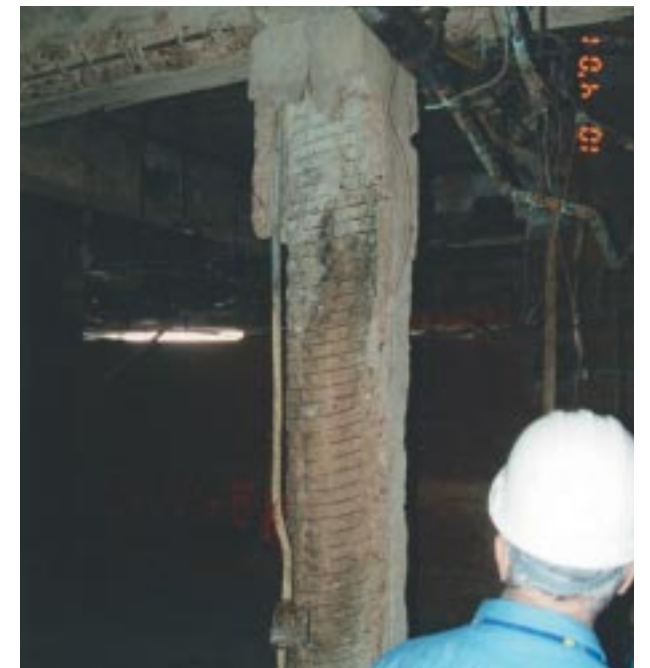
Figure 5.31 Fire damage to column in second story

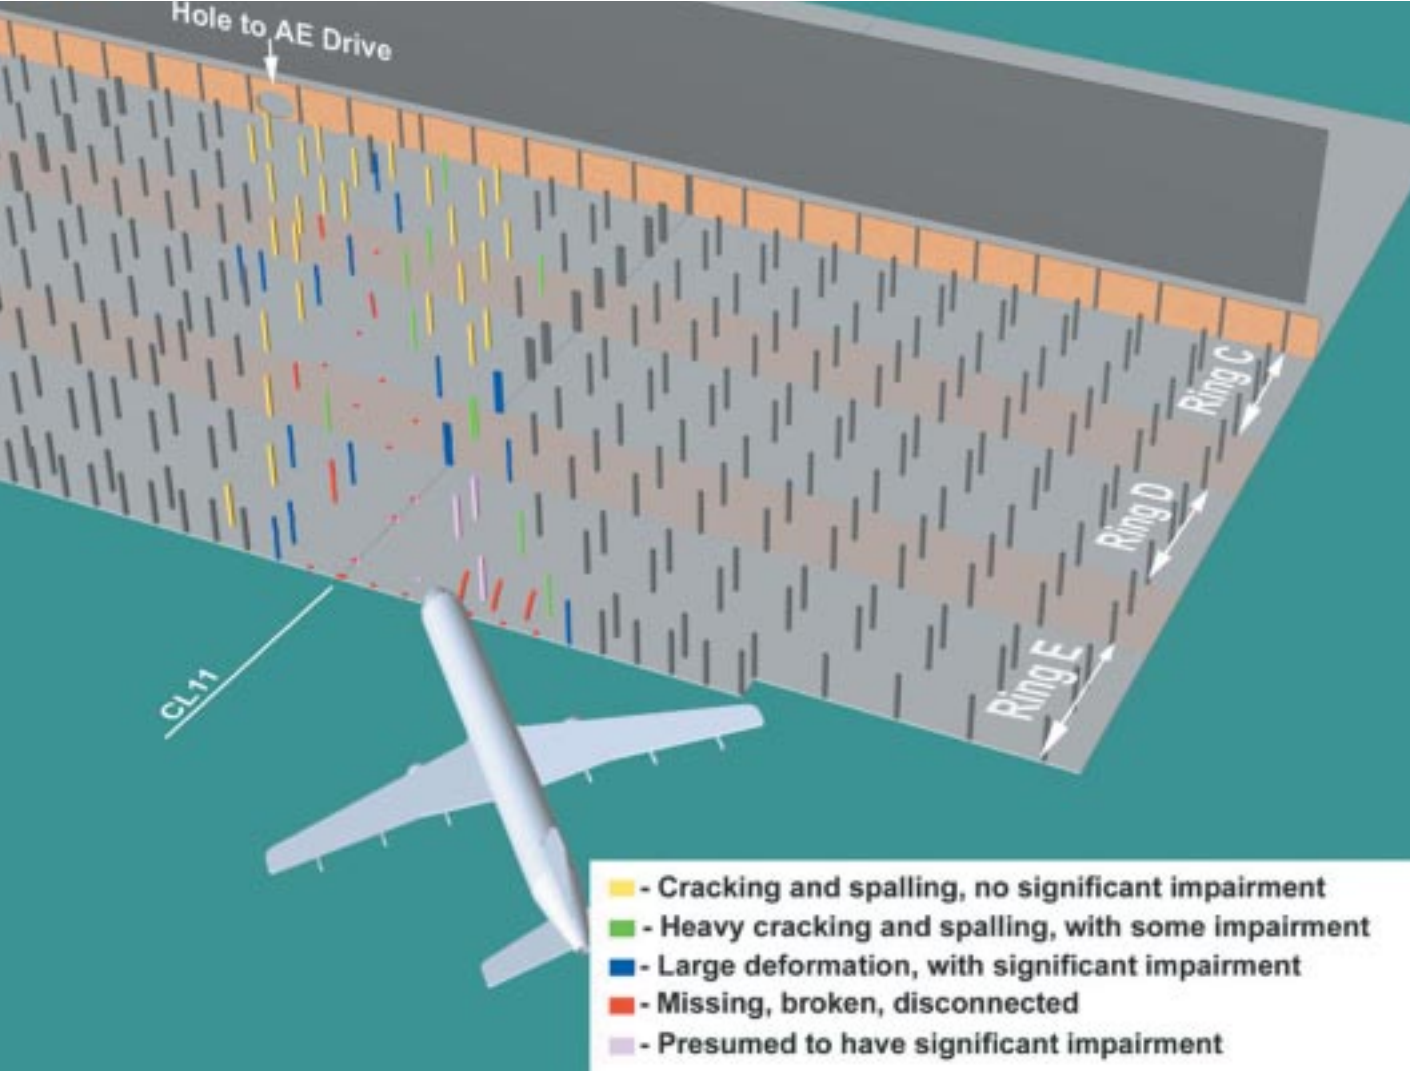
Damage to the first-floor columns is summarized in figures 6.2 and 6.3. In formulating opinions about columns in the collapse area, the BPS team interpreted photographs taken after impact and before collapse.

Figure 6.2 Damage to columns in first story viewed along path of aircraft

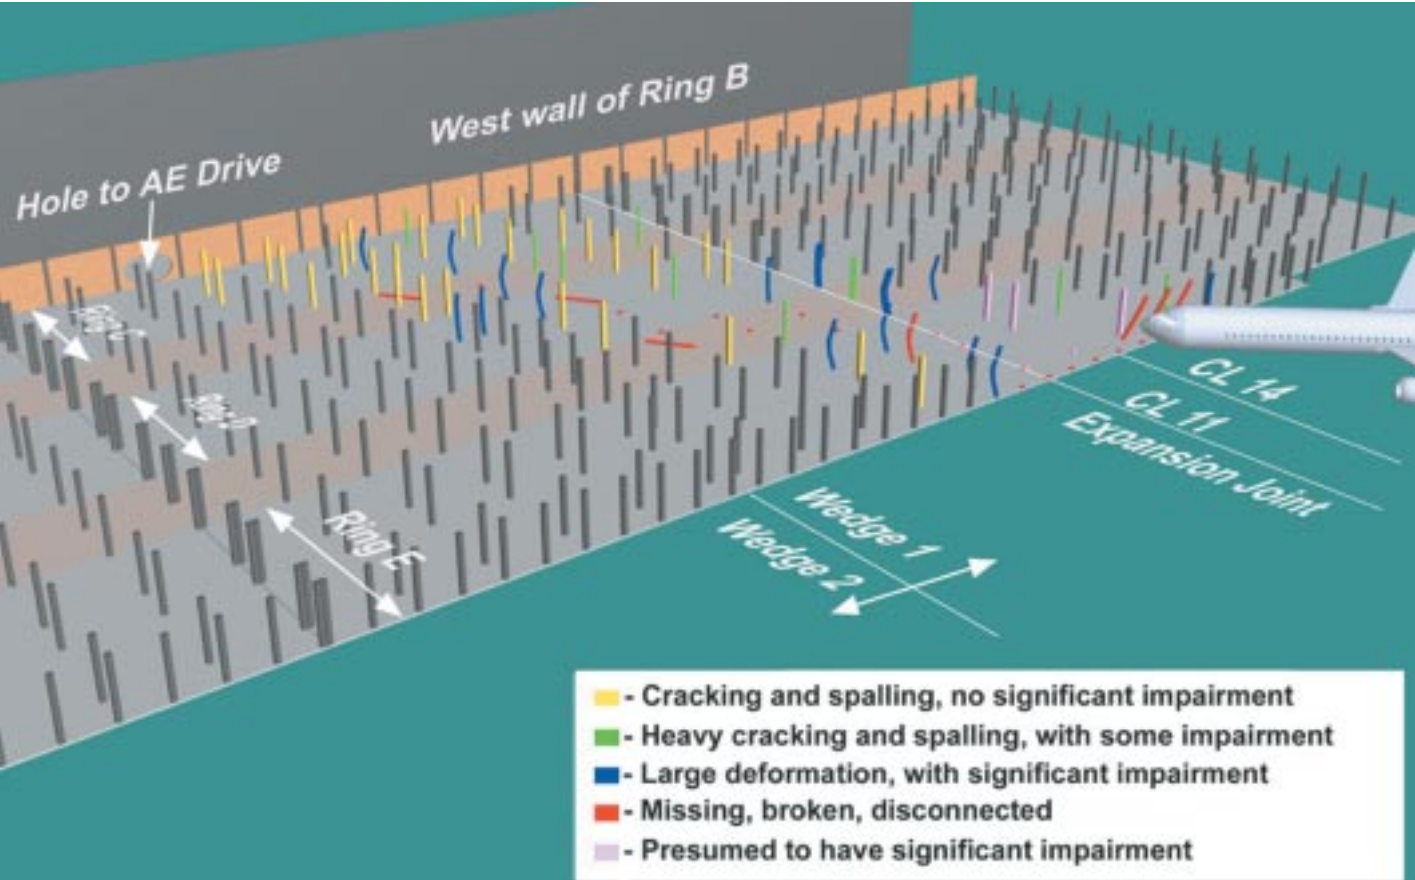
Figure 6.3 Damage to columns in first story viewed across path of aircraft

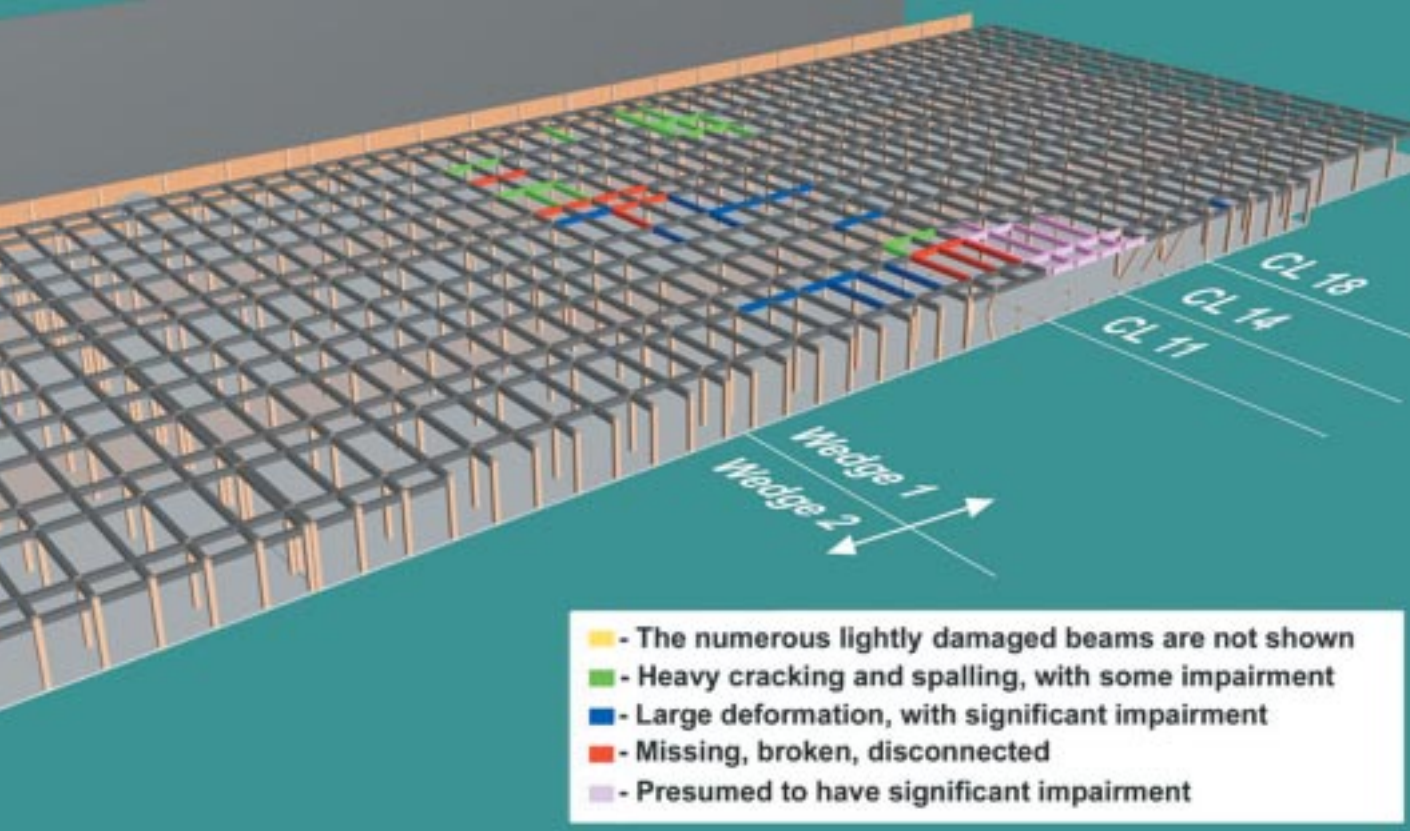
Figure 6.4 Damage to second-story beams

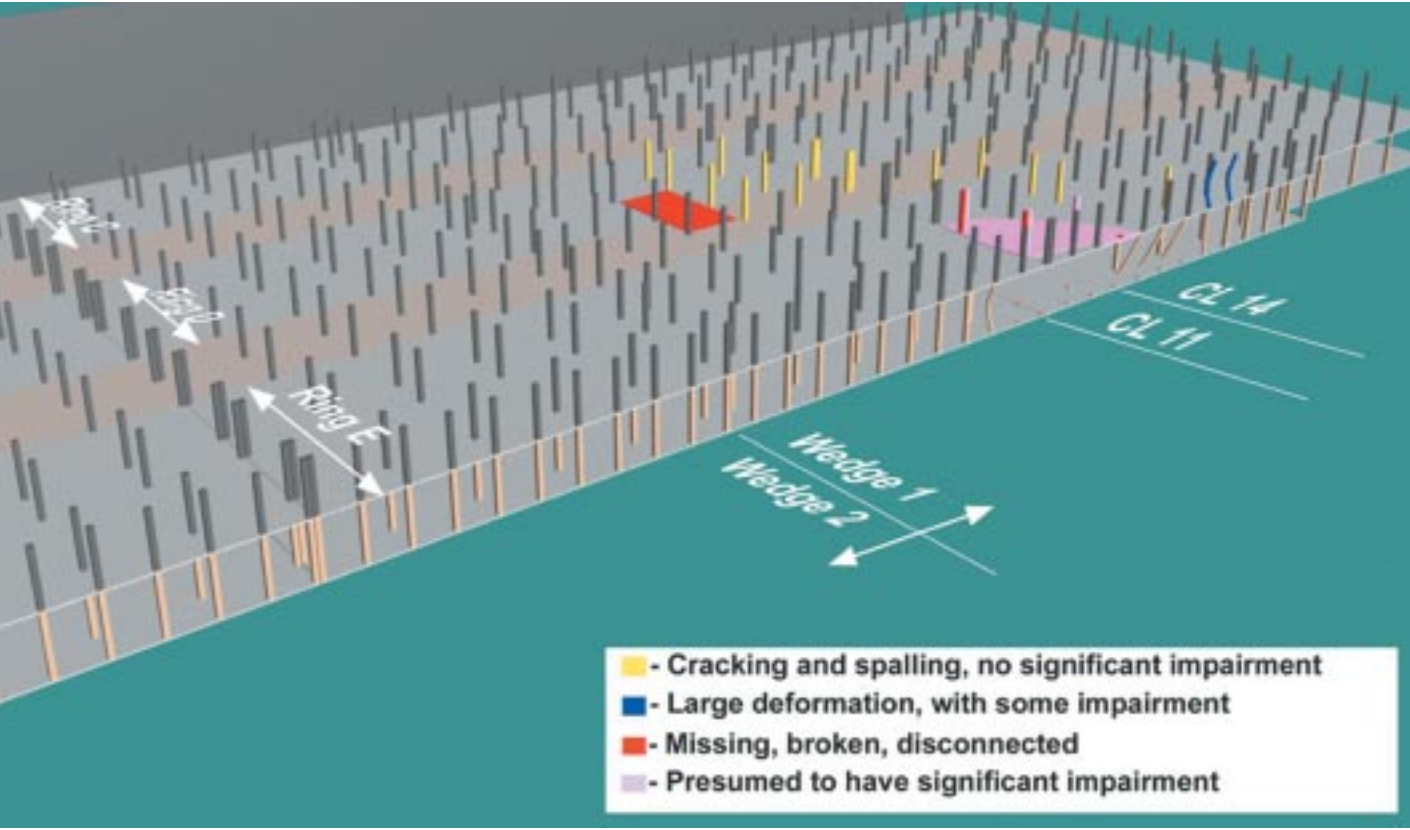
Figure 6.5 Damage to columns and slab in second story

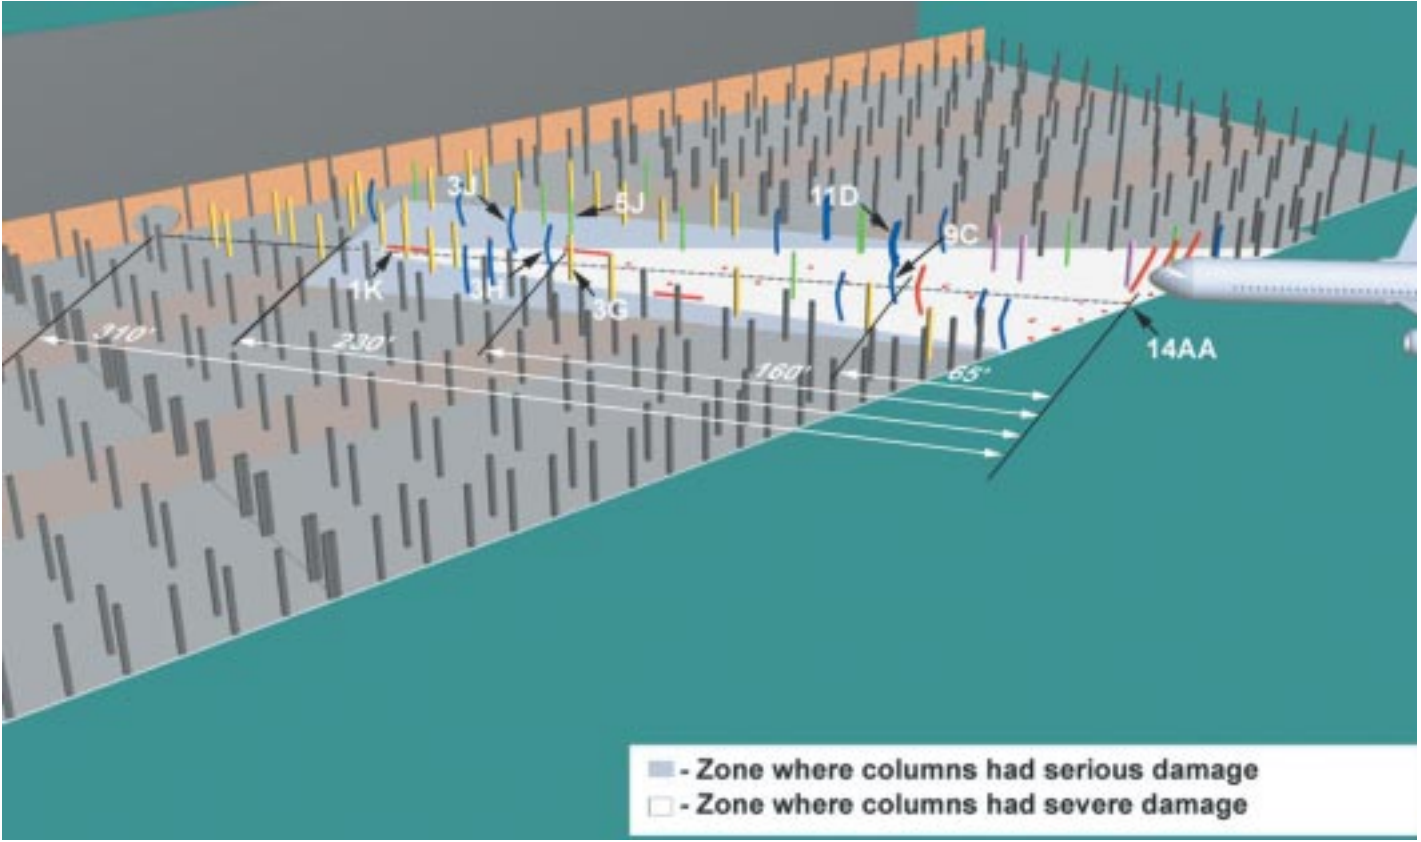
Figure 6.6 Damage regions in first story

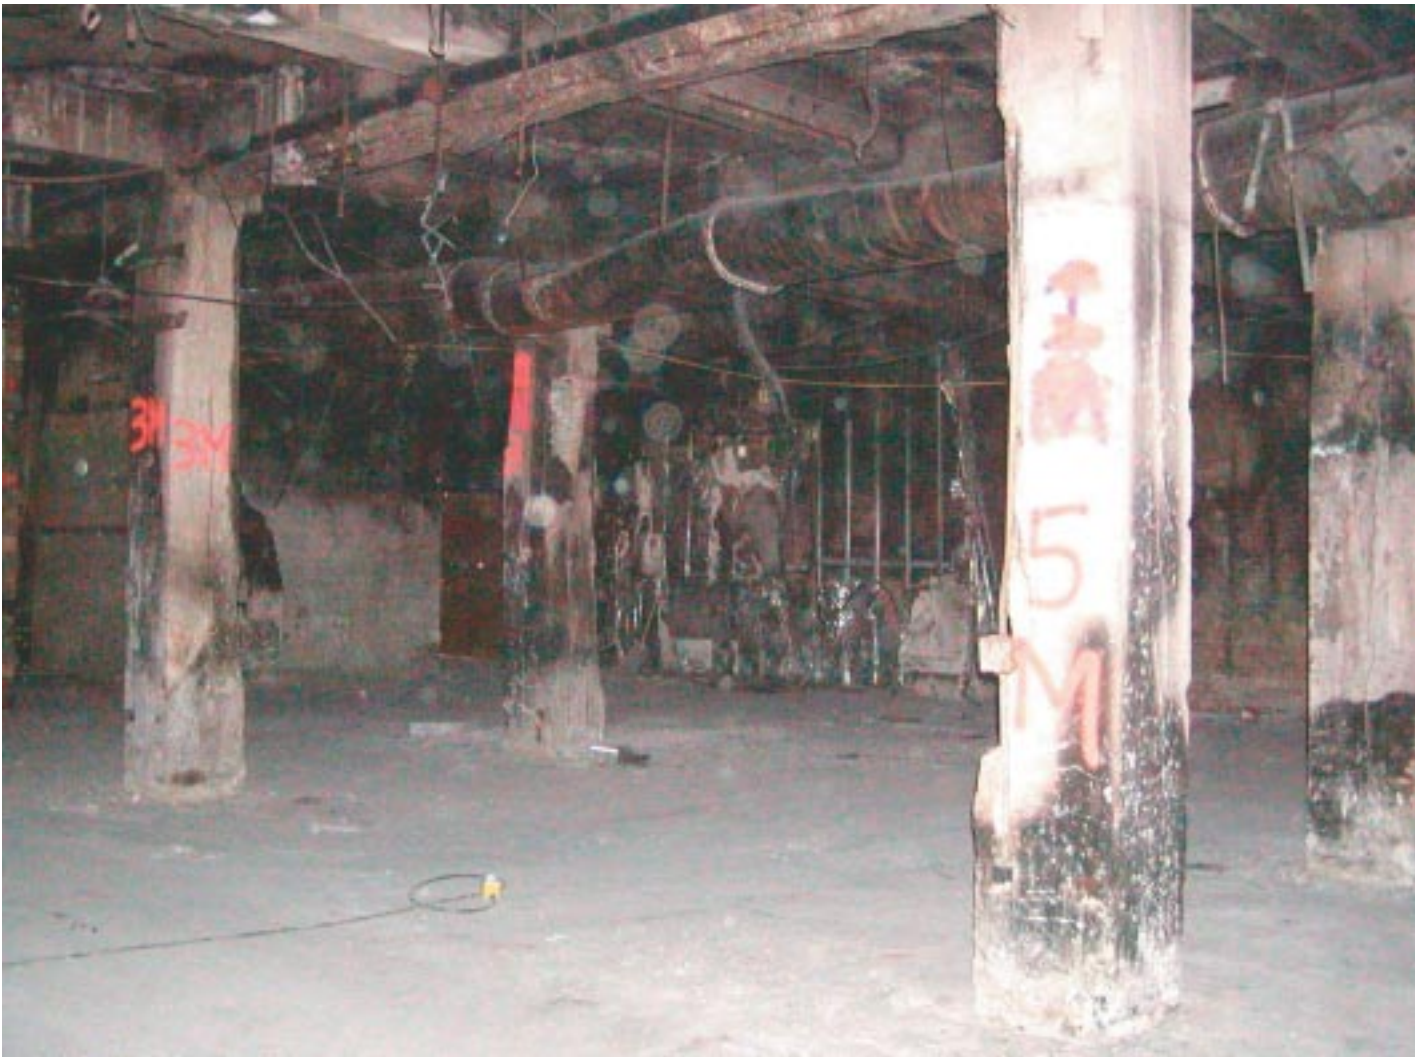
Figure 6.8 First-story columns 5N and 5M

Figures 6.8 and 6.9 show first-floor columns 5M, 5N, 3M, and 3N at the time of the BPS team visit. These columns are located in Ring C, toward the end of the damage path. All four sustained
