# THE PENTAGON BUILDING PERFORMANCE REPORT

January 2003

Following the September 11 crash at the Pentagon of an airliner commandeered by terrorists, the American Society of Civil Engineers established a building performance study team to examine the damaged structure and make recommendations for the future. The members of the team reviewed available information on the structure and the crash loading and drew on focused assessments by others. In addition to analyzing the essential features of column response to impact, they investigated the residual frame capacity and the structural response to the fire. Plausible mechanisms for the response of the structure to the crash were established. Recommendations are offered for future design and construction along with suggestions for research and development.

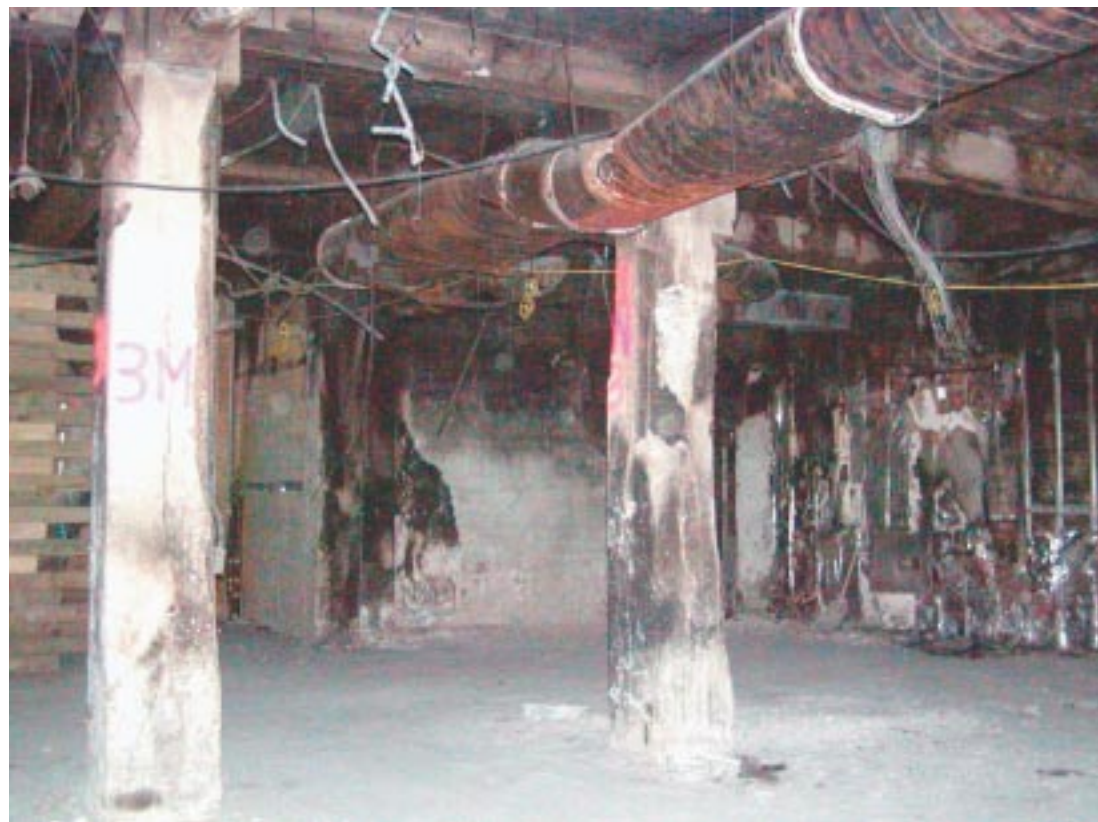
Figure 6.9 First-story columns 3M and 3N

Figures 6.8 and 6.9 show first-floor columns 5M, 5N, 3M, and 3N at the time of the BPS team visit. These columns are located in Ring C, toward the end of the damage path. All four sustained

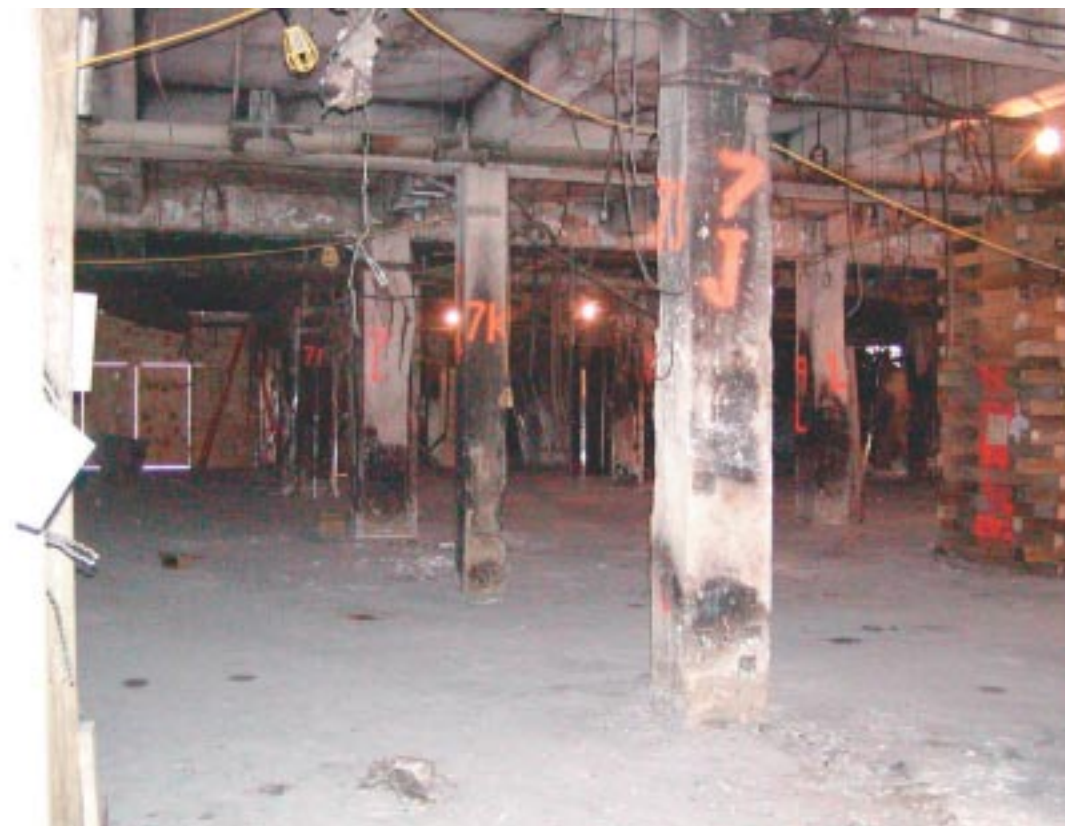
Figure 6.10 First-story columns 7J, 7K, and 7L

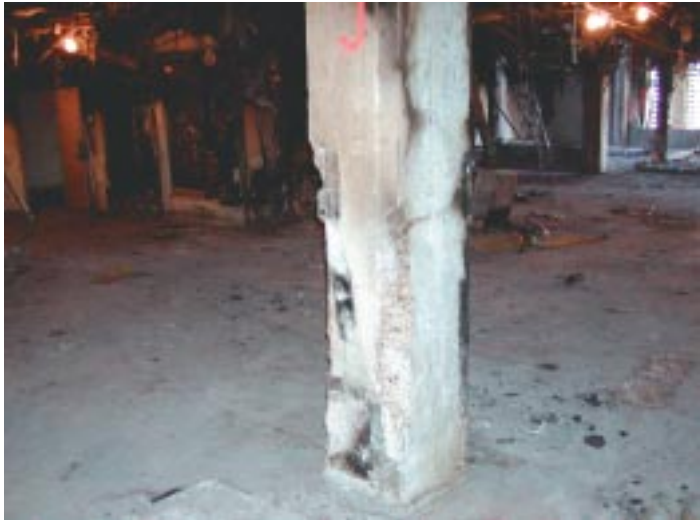
Figure 6.11 First-story column 7J

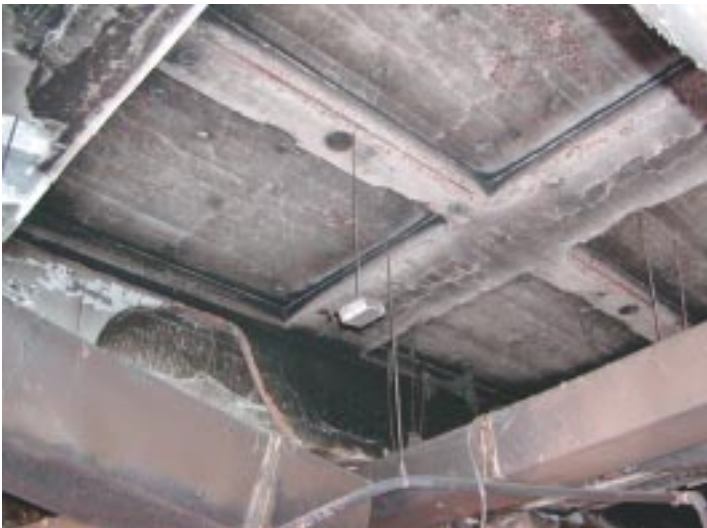
Figure 6.12 Fire damage to third-floor (light well) beams

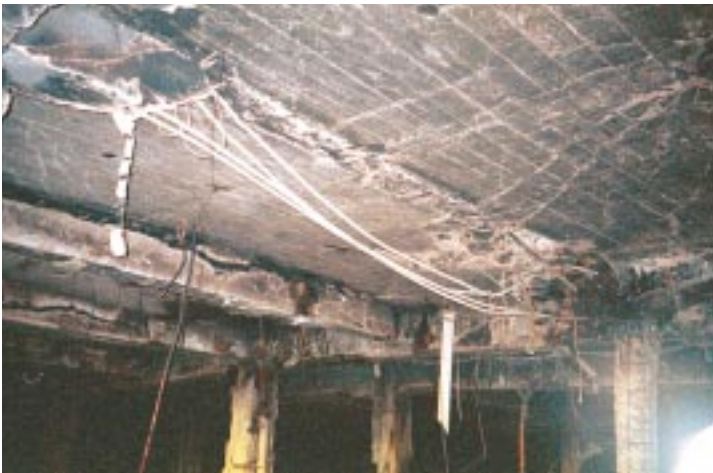
Figure 6.13 Concrete stripped from second-floor beam at grid 9 between grids A and B; extensive cracking in slab

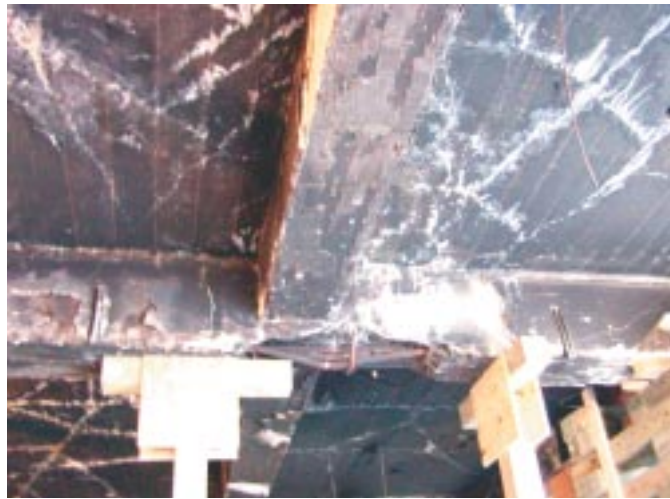
Figure 6.14 Fire-damaged second-floor beams

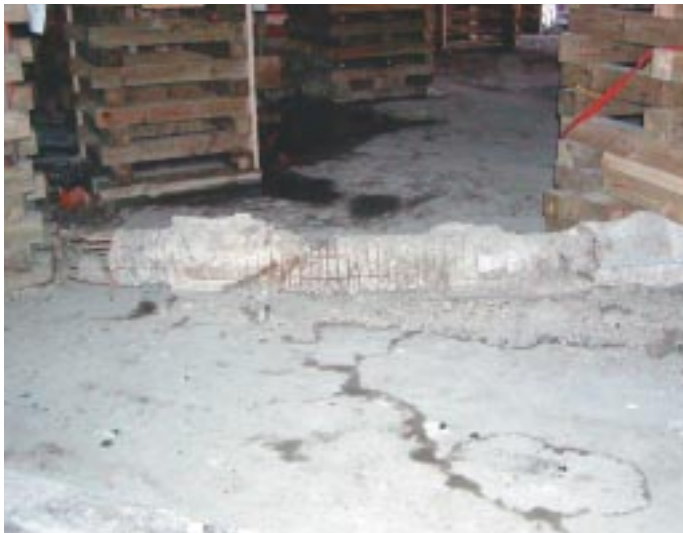
Figure 7.5a Column impacted and torn off at supports

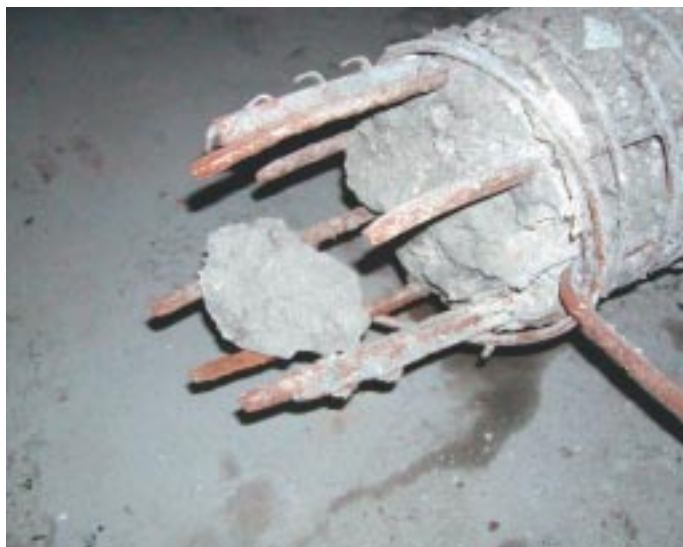
Figure 7.5b Ends of fractured reinforcing bars showing necking

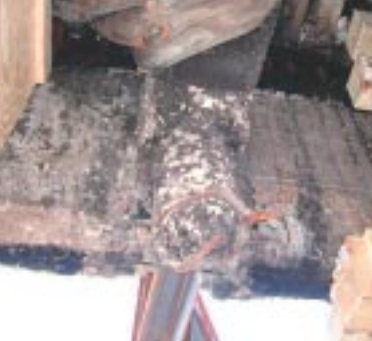
| COLUMN LABEL | DESCRIPTION OF DAMAGE | PHOTO (IF AVAILABLE) |
|---|---|---|
| 10AA | <ul style="list-style-type: none"><li>• Missing</li><li>• Remaining upper section connected to is stripped to spiral reinforcement</li><li>• Shored</li></ul> | |

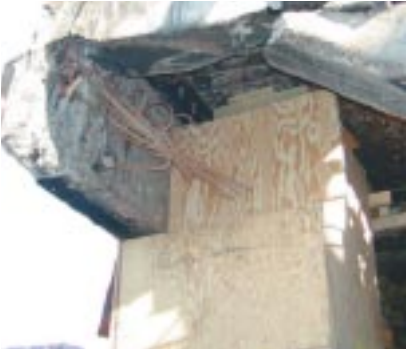
| COLUMN LABEL | DESCRIPTION OF DAMAGE | PHOTO (IF AVAILABLE) |
|---|---|---|
| 11AA | <ul style="list-style-type: none"><li>• Missing</li><li>• Remnants of 8 #8 deformed bars visible at ceiling</li><li>• Shored</li></ul> | |

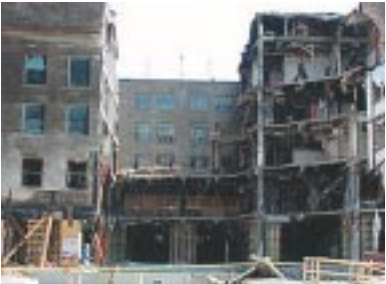
| COLUMN LABEL | DESCRIPTION OF DAMAGE | PHOTO (IF AVAILABLE) |
|---|---|---|
| 12AA, 13AA,14AA,15AA, 16AA, 17AA | <ul style="list-style-type: none"><li>• Missing</li></ul> | |

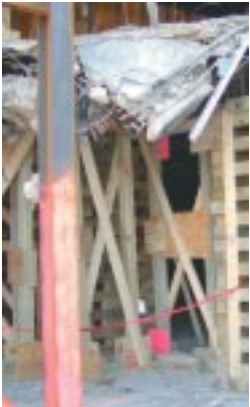
| COLUMN LABEL | DESCRIPTION OF DAMAGE | PHOTO (IF AVAILABLE) |
|---|---|---|
| 11A | <ul style="list-style-type: none"><li>• Missing</li><li>• Shored</li></ul> | |

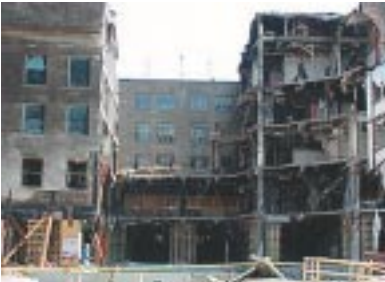
| COLUMN LABEL | DESCRIPTION OF DAMAGE | PHOTO (IF AVAILABLE) |
|---|---|---|
| 13A,15A | <ul style="list-style-type: none"><li>• Missing</li></ul> | |

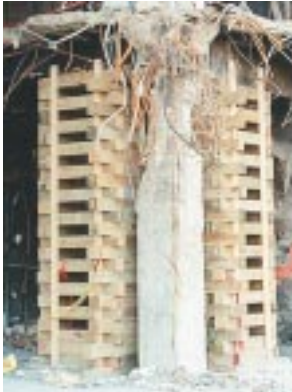
| COLUMN LABEL | DESCRIPTION OF DAMAGE | PHOTO (IF AVAILABLE) |
|---|---|---|
| 17A | <ul style="list-style-type: none"><li>• Stripped to spiral reinforcement at top of column</li><li>• Shored</li></ul> | |

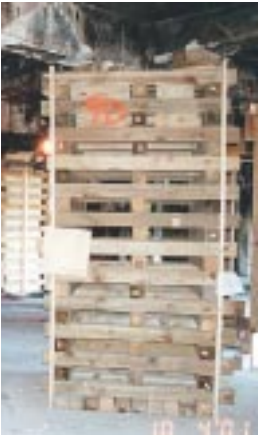
| COLUMN LABEL | DESCRIPTION OF DAMAGE | PHOTO (IF AVAILABLE) |
|---|---|---|
| 9D | <ul style="list-style-type: none"> <li>Missing</li> <li>Shored</li> </ul> | |

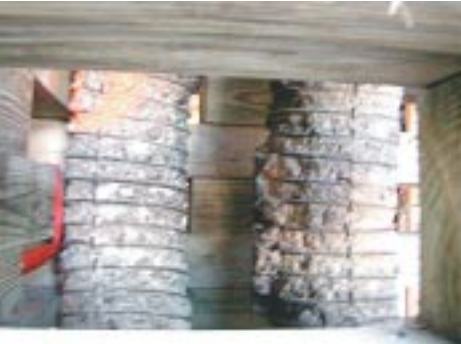
| COLUMN LABEL | DESCRIPTION OF DAMAGE | PHOTO (IF AVAILABLE) |
|---|---|---|
| 11D | <ul style="list-style-type: none"> <li>Bowed</li> <li>Stripped to spiral reinforcement</li> <li>Shored</li> </ul> | |

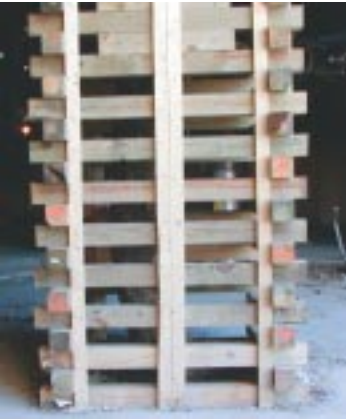
| COLUMN LABEL | DESCRIPTION OF DAMAGE | PHOTO (IF AVAILABLE) |
|---|---|---|
| 13D | <ul style="list-style-type: none"> <li>Stripped to spiral reinforcement</li> <li>Bowed to Northeast</li> <li>Shored</li> </ul> | |

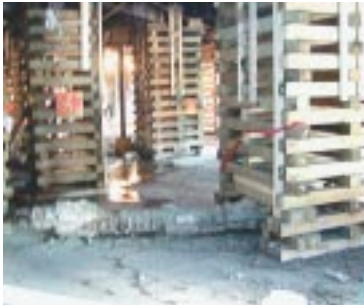
| COLUMN LABEL | DESCRIPTION OF DAMAGE | PHOTO (IF AVAILABLE) |
|---|---|---|
| 5E | <ul style="list-style-type: none"><li>• Downed</li><li>• Stripped to spiral reinforcement</li><li>• Shored</li></ul> | |

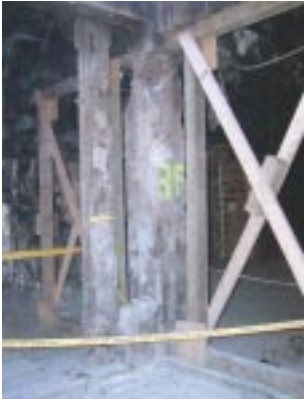
| COLUMN LABEL | DESCRIPTION OF DAMAGE | PHOTO (IF AVAILABLE) |
|---|---|---|
| 3F | <ul style="list-style-type: none"><li>• Spalled to spiral reinforcement at top</li></ul> | |

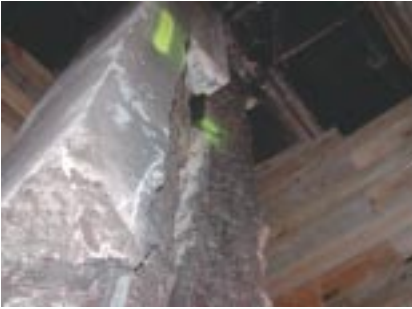
| COLUMN LABEL | DESCRIPTION OF DAMAGE | PHOTO (IF AVAILABLE) |
|---|---|---|
| 11F | <ul style="list-style-type: none"><li>• Impacted, bowed</li><li>• Stripped to spiral reinforcement</li><li>• Shored</li></ul> | |

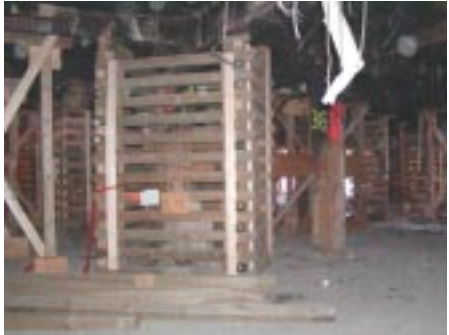
| COLUMN LABEL | DESCRIPTION OF DAMAGE | PHOTO (IF AVAILABLE) |
|---|---|---|
| 3G | <ul style="list-style-type: none"><li>• Slightly blackened</li></ul> | |

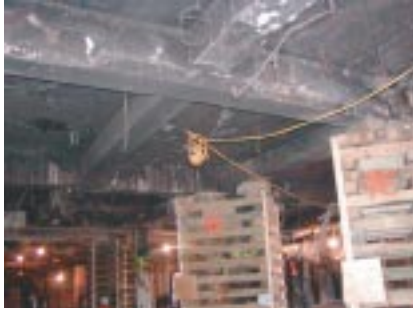
| COLUMN LABEL | DESCRIPTION OF DAMAGE | PHOTO (IF AVAILABLE) |
|---|---|---|
| 9G | <ul style="list-style-type: none"> <li>• Moderate spalling</li> <li>• Steel visible on northwest side at midsection</li> </ul> | |

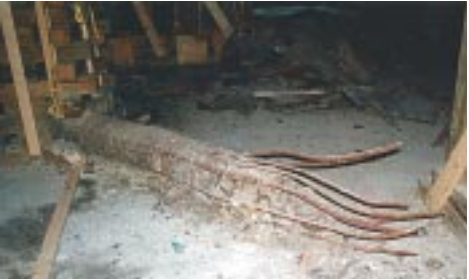
| COLUMN LABEL | DESCRIPTION OF DAMAGE | PHOTO (IF AVAILABLE) |
|---|---|---|
| 5H | <ul style="list-style-type: none"> <li>• Downed</li> <li>• Stripped to spiral reinforcement</li> <li>• Shored</li> </ul> | |

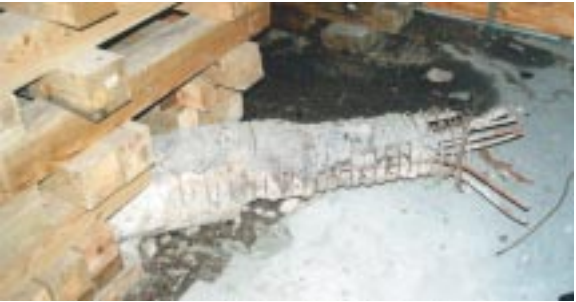
| COLUMN LABEL | DESCRIPTION OF DAMAGE | PHOTO (IF AVAILABLE) |
|---|---|---|
| 1K-South | <ul style="list-style-type: none"><li>• Downed</li><li>• Stripped to spiral reinforcement</li><li>• Shored</li></ul> | |

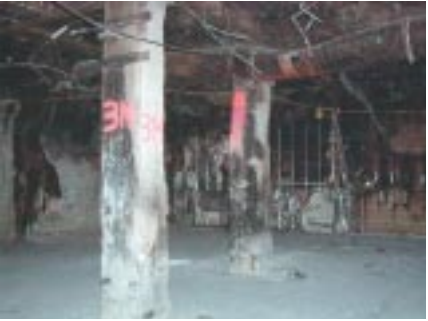
| COLUMN LABEL | DESCRIPTION OF DAMAGE | PHOTO (IF AVAILABLE) |
|---|---|---|
| 3M-North | <ul style="list-style-type: none"><li>Damaged (per FBI)</li></ul> | |
