# THE PENTAGON BUILDING PERFORMANCE REPORT

January 2003

Following the September 11 crash at the Pentagon of an airliner commandeered by terrorists, the American Society of Civil Engineers established a building performance study team to examine the damaged structure and make recommendations for the future. The members of the team reviewed available information on the structure and the crash loading and drew on focused assessments by others. In addition to analyzing the essential features of column response to impact, they investigated the residual frame capacity and the structural response to the fire. Plausible mechanisms for the response of the structure to the crash were established. Recommendations are offered for future design and construction along with suggestions for research and development.

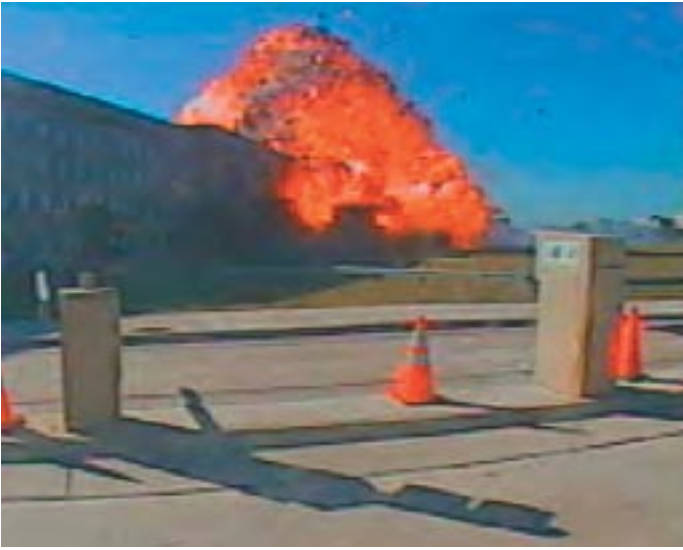
Figure 1.2 Aircraft impact

At 9:38 A.M. on September 11 an airliner was flown into the first story of the Pentagon. The impact occurred in the renovated portion of the building approximately 140 ft to the south of the boundary between the renovated section and the next section scheduled to be renovated. (Figure 1.2, a photograph taken by a security camera, shows the plane impacting the building at ground level.) The aircraft sliced through the building into the section not yet renovated. The impact and the fire initiated by the fuel in the airplane that immediately spread widely in the structure took the lives of all 64 people aboard the aircraft and 125 occupants of the Pentagon.

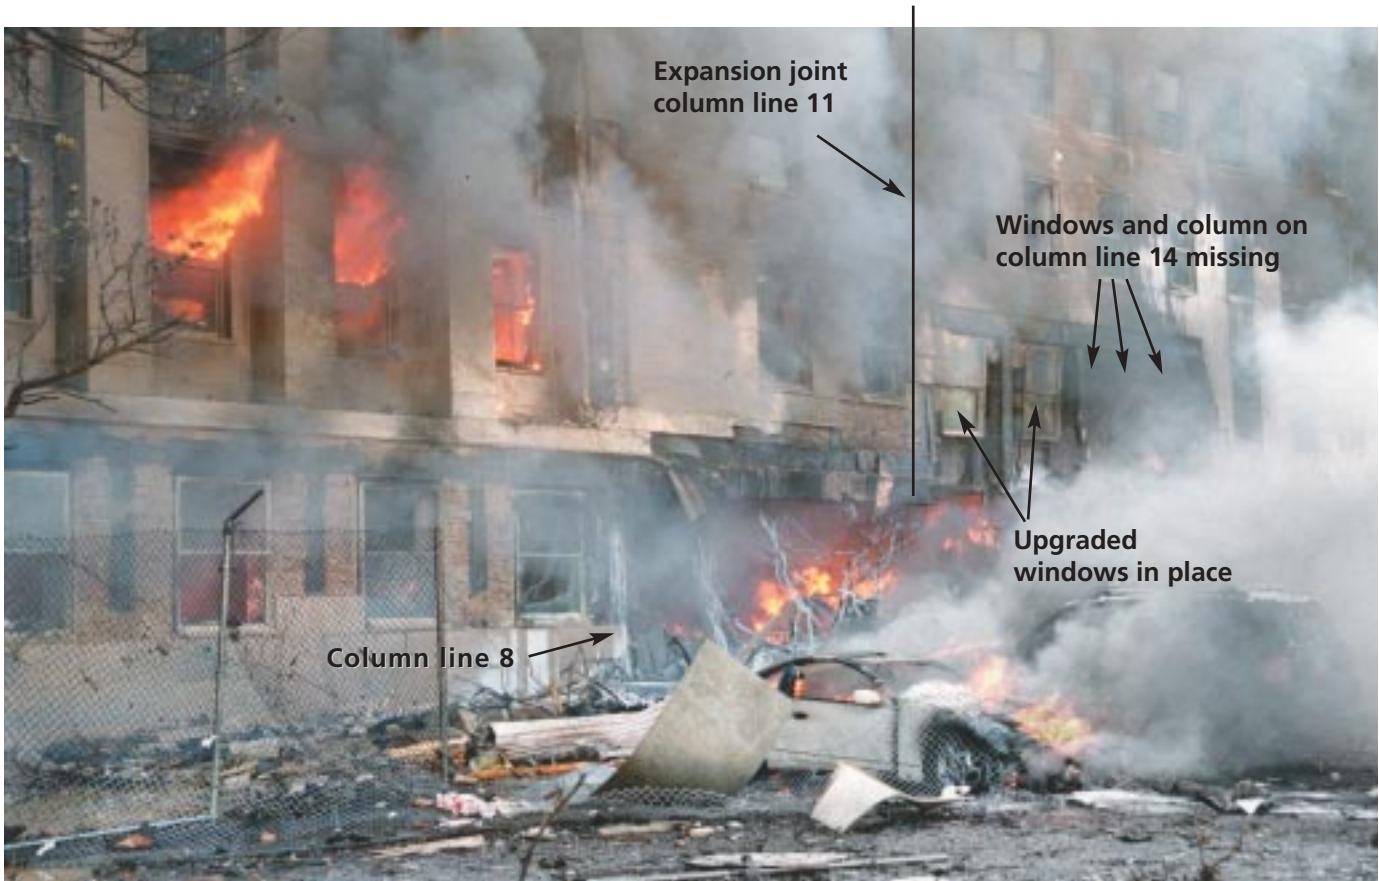
Figure 3.8 Northern portion of impact area before collapse

A photograph (figure 3.8) taken by the Associated Press before the building to the south of the expansion joint collapsed provides useful information that the BPS team could not observe at the site. This photograph shows that the portion of the building that subsequently collapsed was displaced vertically by approximately 18 in. to 2 ft relative to the building north of the expansion joint. The facade was missing on the first floor as far north as column line 8 (the expansion joint is at column line 11), and on the second floor, the facade was missing between column lines 11 and 15. However, windows and their reinforcing frames were still in place between column lines 11 and 13 on the second floor.

The photograph shows that blast-resistant glass installed as part of the Pentagon renovation was not broken by the impact or the

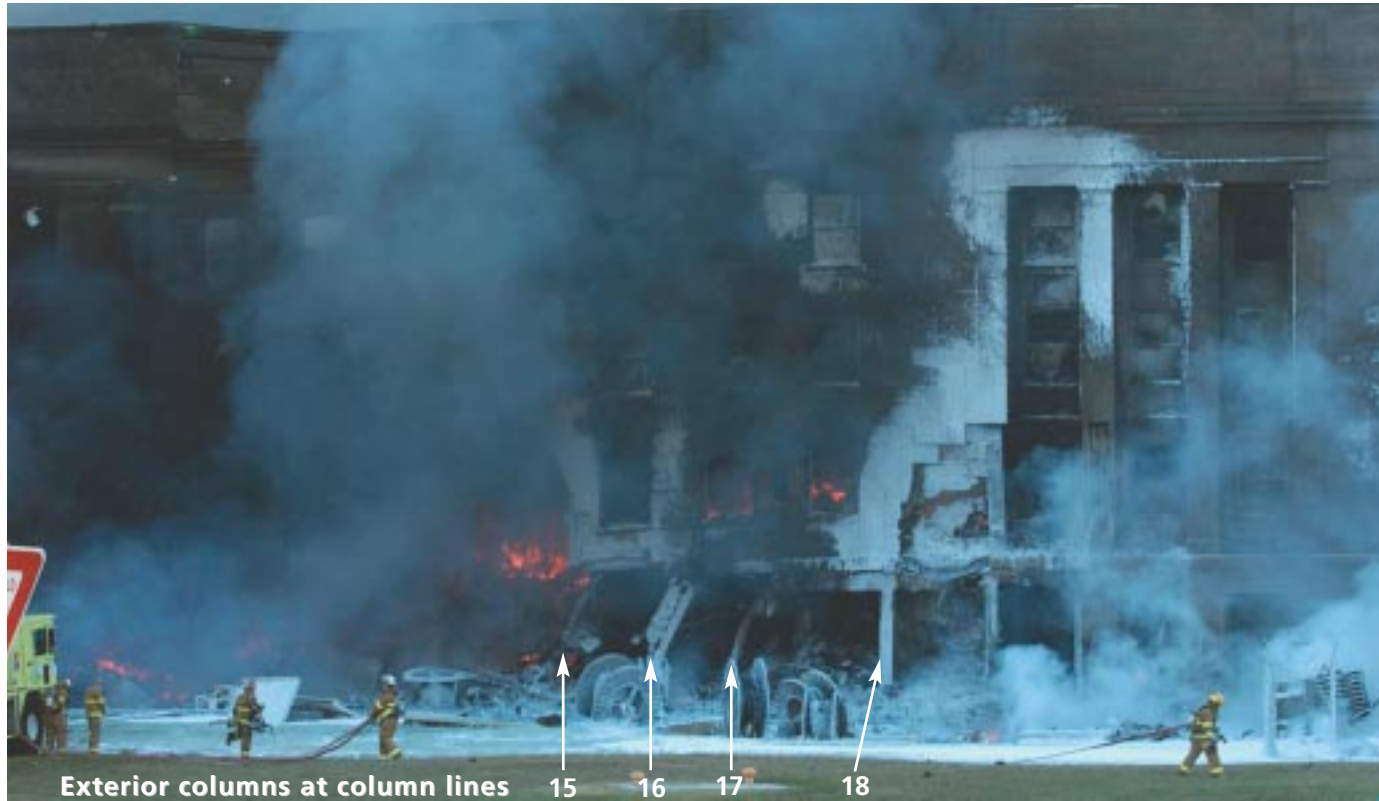
Figure 3.9 Southern portion of impact area before collapse

A second photograph (figure 3.9) taken before the collapse reveals that first-floor exterior columns on column lines 15, 16, and 17 were severely distorted but still attached at least at their top ends to the second-floor framing. The vertical displacement noted previously also is evident in this photograph.

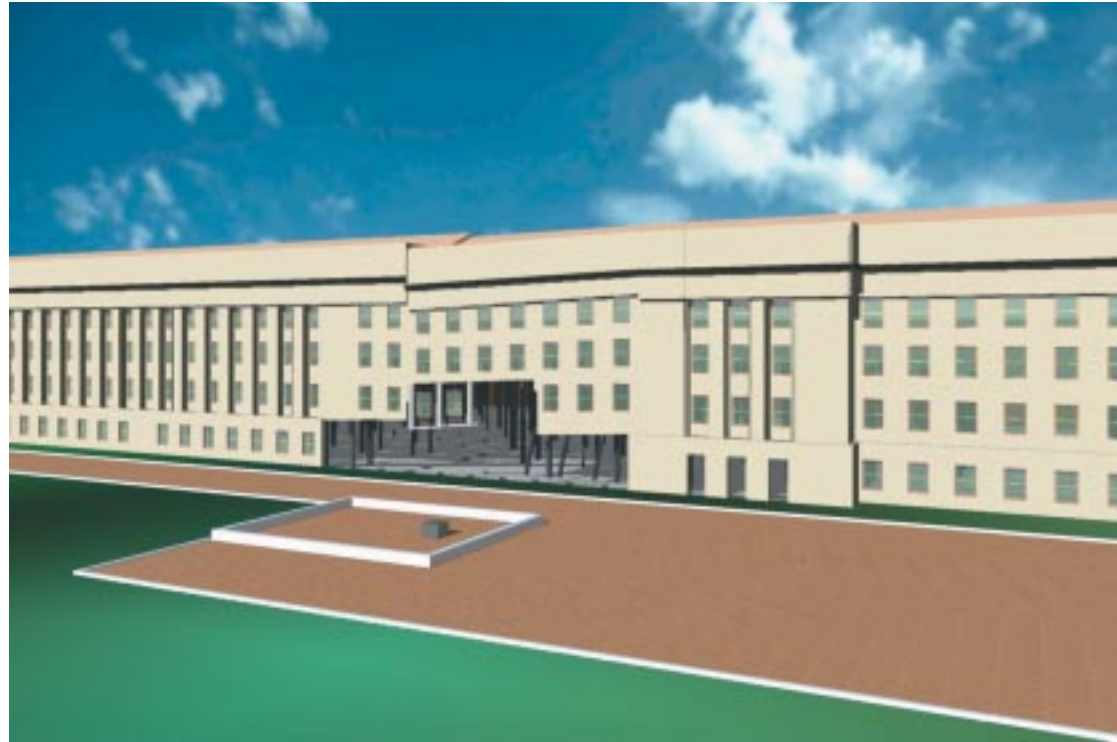
Figure 3.10 Impact location before collapse

The precollapse state of the structure is illustrated for clarity in figure 3.10.

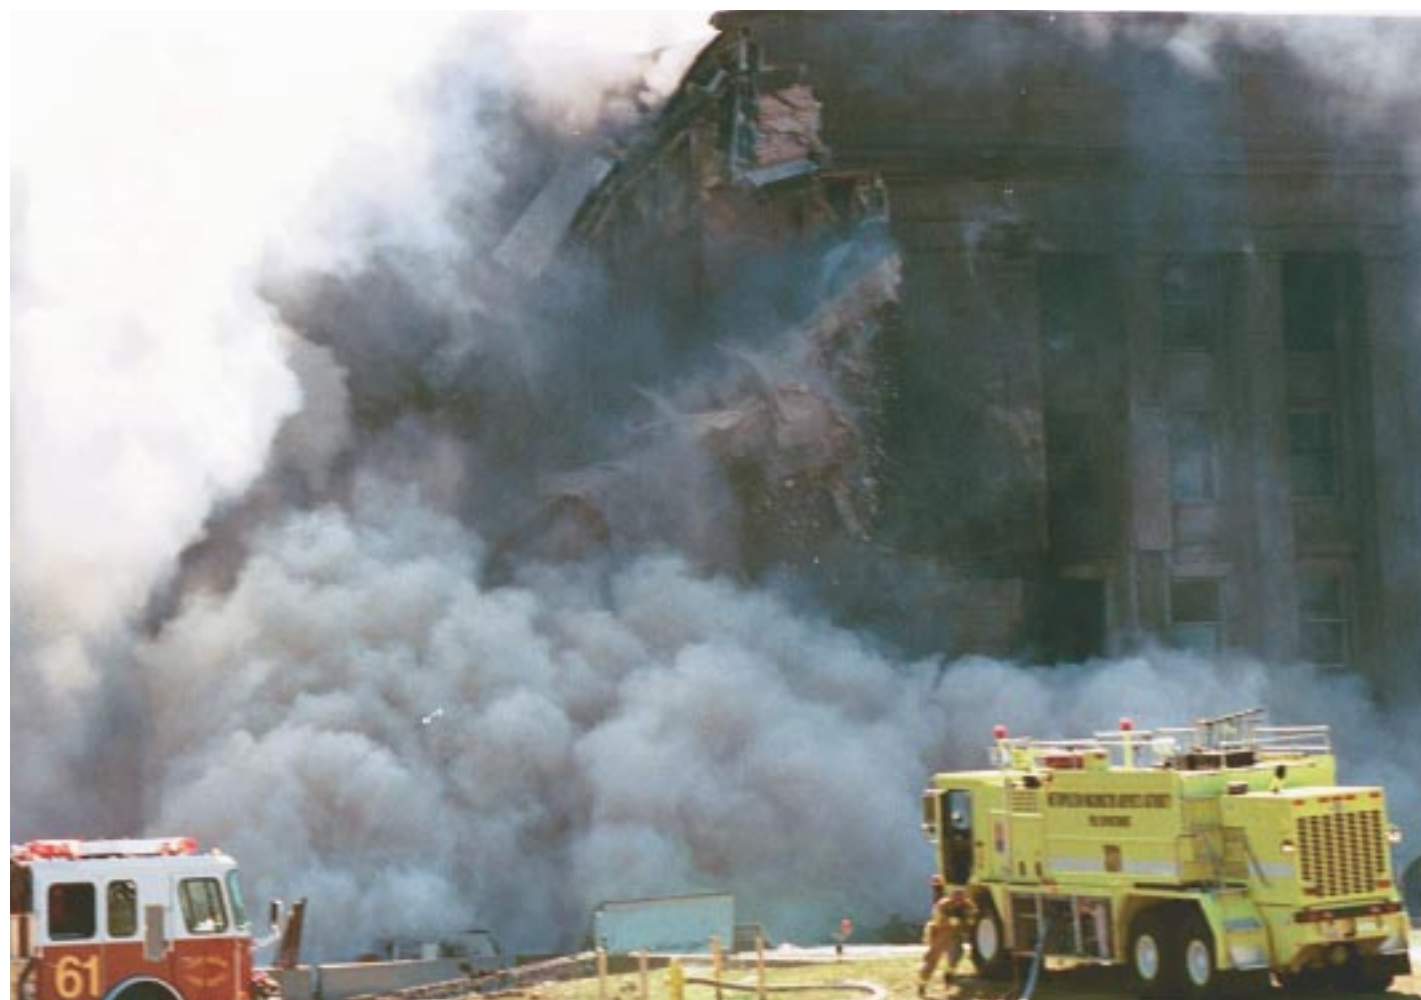
Figure 3.11 Portion of Ring E at moment of collapse

Figure 3.11 is a photograph taken at the moment of collapse, approximately 20 minutes after the aircraft struck the west wall of the Pentagon. The collapse extended to approximately column line 18 on the west face of the building.

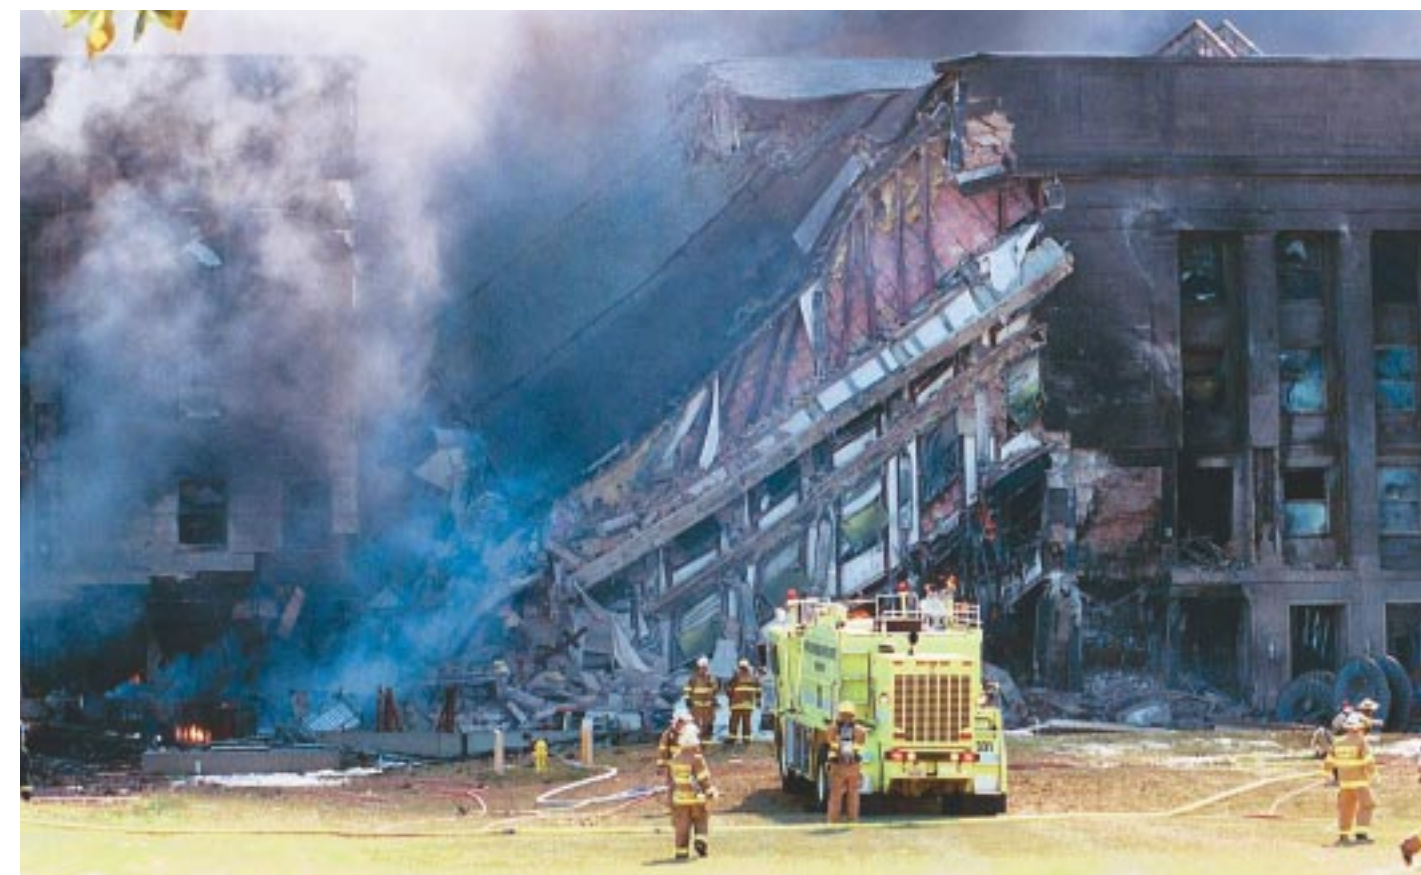
Figure 3.12 Ring E after collapse

The structure was able to maintain this deformed shape for approximately 20 minutes, at which point all five levels of Ring E collapsed from column line 11 to approximately column line 18 (figure 3.12).

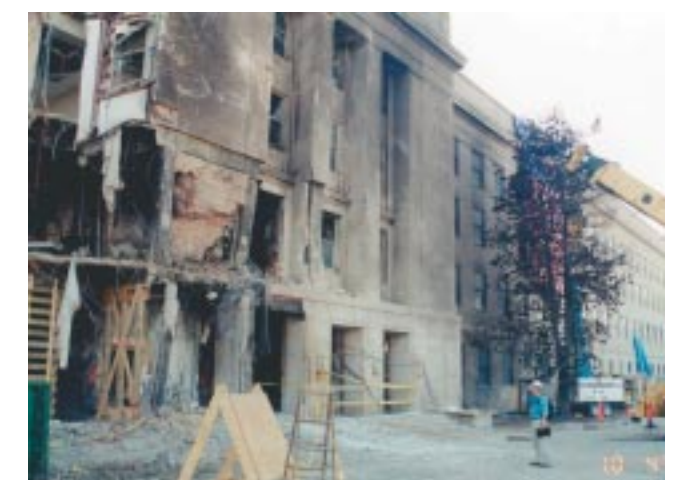
Figure 5.10 Exterior evidence of fire to the south of the impact area

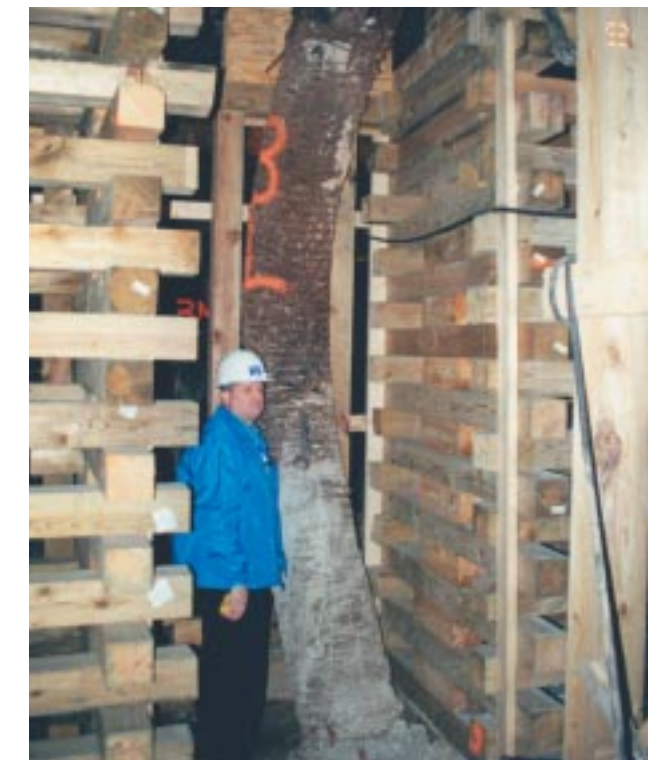
Figure 5.20 Column 3L with large deformation and discrete hinges

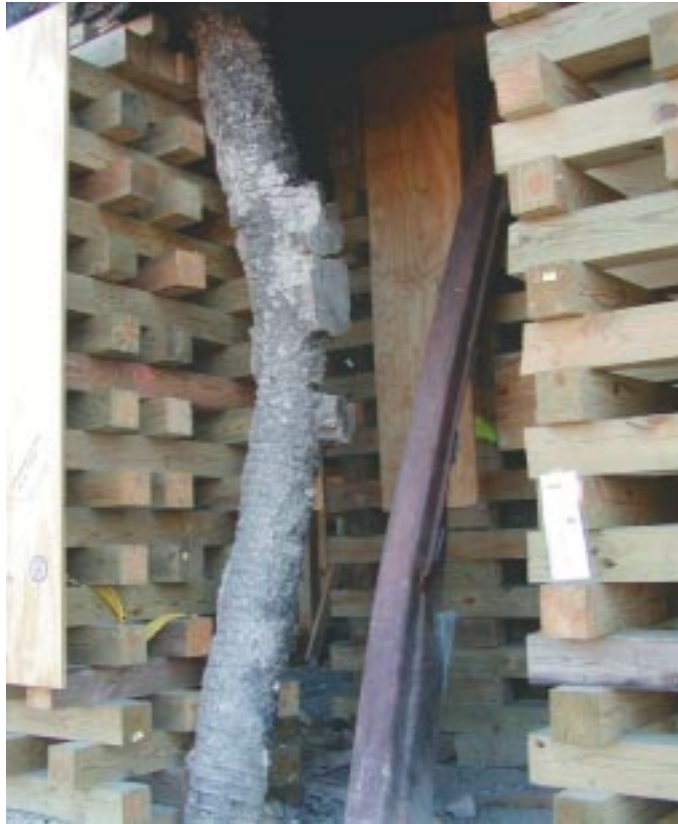
Figure 5.21 Column with triple curvature

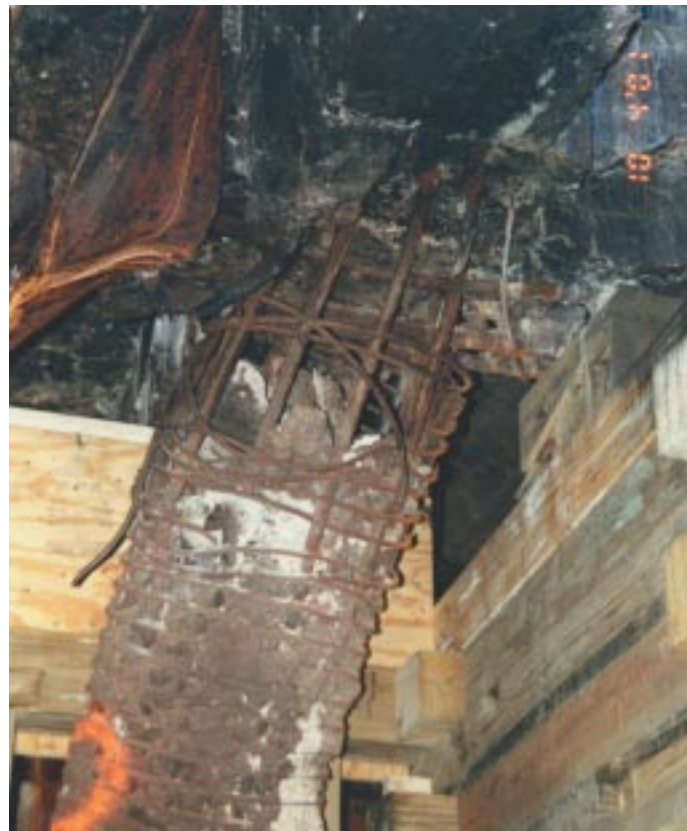
Figure 5.22 Top of column 3L, still attached to underside of second-floor framing

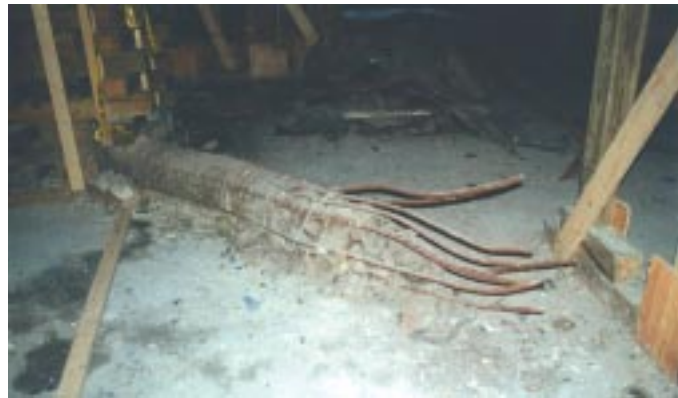
Figure 5.23 Severed column 5H

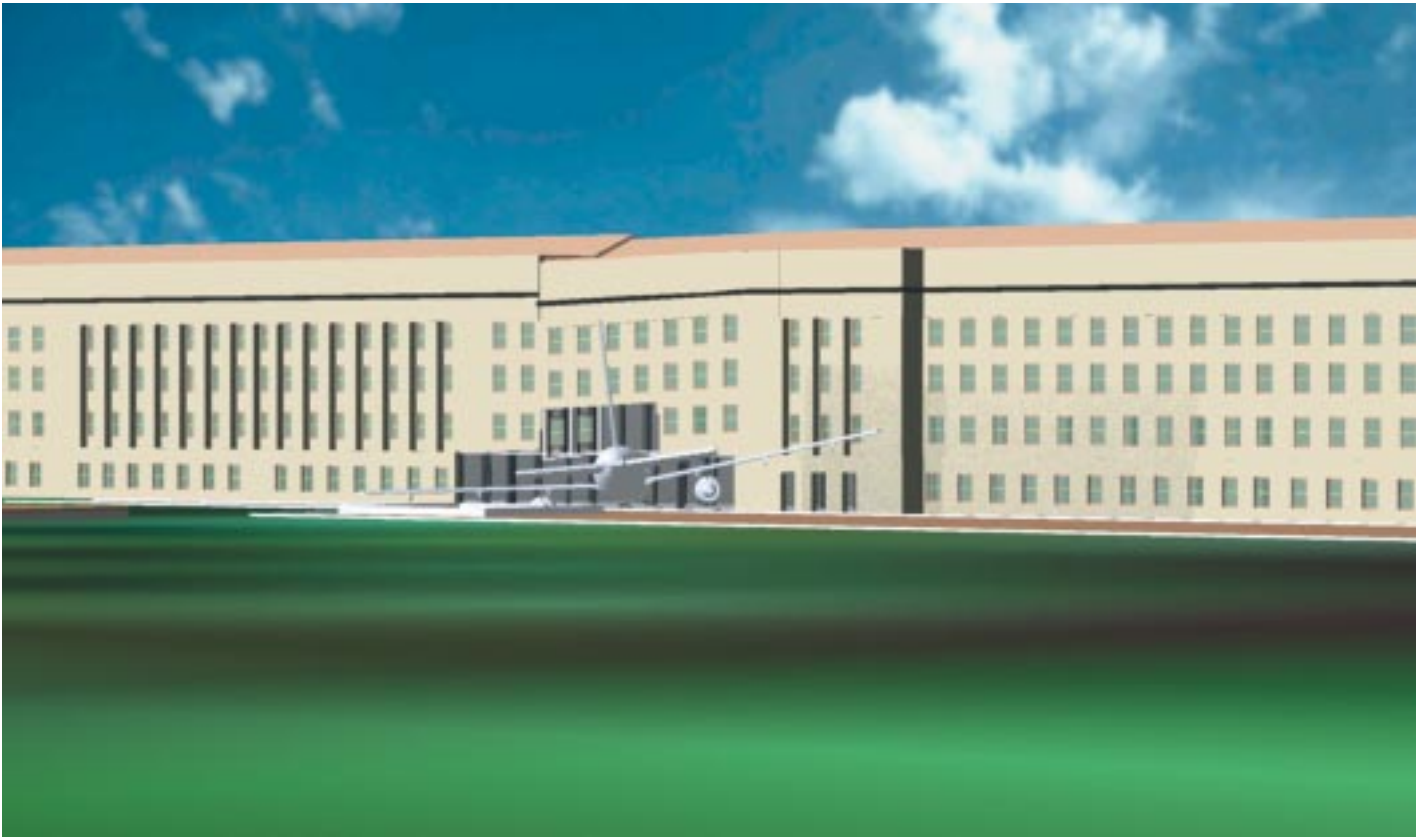
Figure 6.1 Aircraft aligned with damage on west facade

It is possible that less of the right wing than the left wing entered the building because the right wing struck the facade crossing the level of the second-floor slab. The strength of the second-floor slab in its own plane would have severed the right wing approximately at the location of the right engine. The left wing did not encounter a slab, so it penetrated more easily.

In any event, the evidence suggests that the tips of both wings did not make direct contact with the facade of the building and that portions of the wings might have been separated from the

fuselage before the aircraft struck the building. This is consistent with eyewitness statements that the right wing struck a large generator before the aircraft struck the building and that the left engine struck a ground-level, external vent structure. It is possible that these impacts, which occurred not more than 100 ft before the nose of the aircraft struck the building, may have damaged the wings and caused debris to strike the Pentagon facade and the heliport control building.

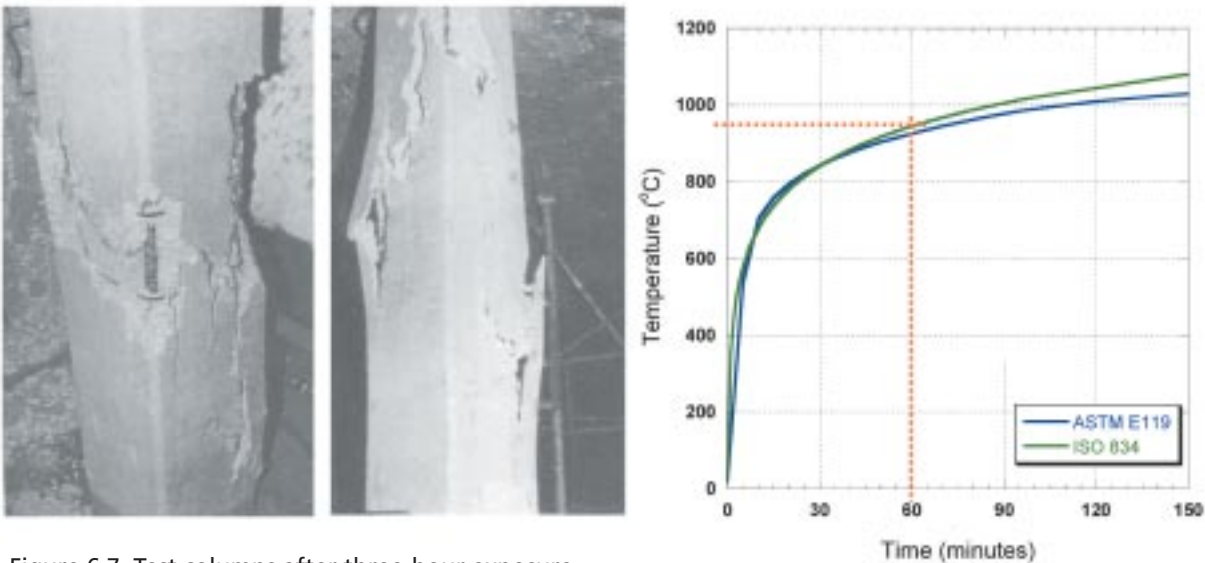
Figure 6.7 Test columns after three-hour exposure

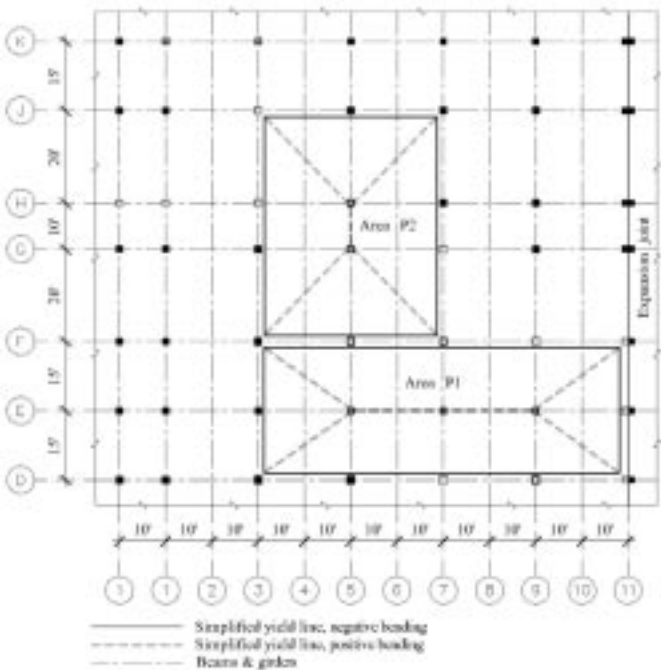
Figure 7.6a Yield line analysis of area with missing columns

column lines, why the structure could tolerate losses of columns. Simplified yield line analyses were also performed for areas within segment P that were missing several columns. Figure 7.6a shows two such areas, P1 and P2. The two areas are shown divided because the light well wall above (see figure 2.10, section 2) provides a stiff and strong support, and the second-story columns were able to act as hangers because the column vertical reinforcement was sufficiently well developed (having the lap enclosed within a spiral may have been a factor). The calculated capacities of the floor systems within P1 and P2 were both over 350 psf, more than twice the dead load. The light well wall was also analyzed for the loads that the area P1 and P2 mechanisms would deliver to it, and this analysis showed that some support from the two significantly impaired columns at 9 and 11 F would have been required to prevent a failure. The spiral reinforcement in those two columns must have been a key factor in preventing a widespread collapse.

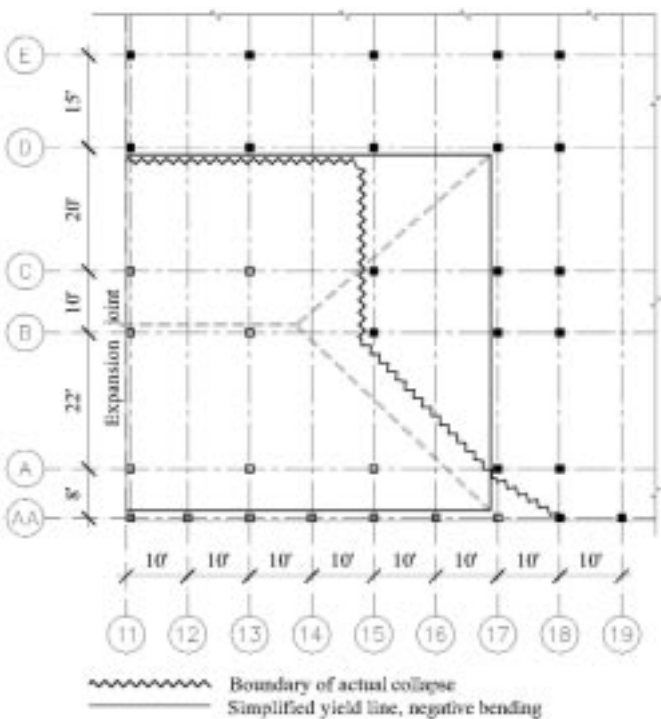
Figure 7.6b Yield line analysis of collapse area, segment Q

Figure 7.6b depicts the segment of the building between column lines 11 and 17 and AA and D. To obtain another perspective of the intrinsic strength of the floor system, its capacity to resist load at room temperature was estimated by assuming that all columns at the intersections of column lines 12 through 16 and AA, A, B, and C were lost. The assumed locations of the negative- and positive-moment yield lines are shown in the figure. The floor-system edge along line 11—the location of the expansion joint—was assumed to be unsupported. The support along line AA was considered to be provided by the facade wall that had not been destroyed by the impact. (An example of a similar phenomenon at a different building is shown in figure 7.7.)

The calculated capacity for the failure condition shown ideally in figure 7.6b was approximately 160 psf (with the dimension  $x$  set at 35 ft, corresponding to the minimum calculated yield load). For the assumed boundary, material, and support conditions, the floor system at level two would have been able to support itself over the assumed unsupported area. It is plausible to assume that the columns at the intersections of line AA with lines 11 through 16 were not functional at the time the photograph that constitutes figure 3.8 (section 3) was taken. Photographs taken immediately after the impact (figures 3.8 and 3.9, section 3) indicate that segment Q might have derived some support from segment P before collapsing. The partial support might have provided a collateral

mechanism for resisting the overall gravity loads on segment Q considered as a building block, but the floor system would still have had to be able to carry itself. The eventual collapse of this section is attributed to the effects of heat from the fire or high-strain creep, possibly exacerbated by the water pumped into the structure to quell the fire.

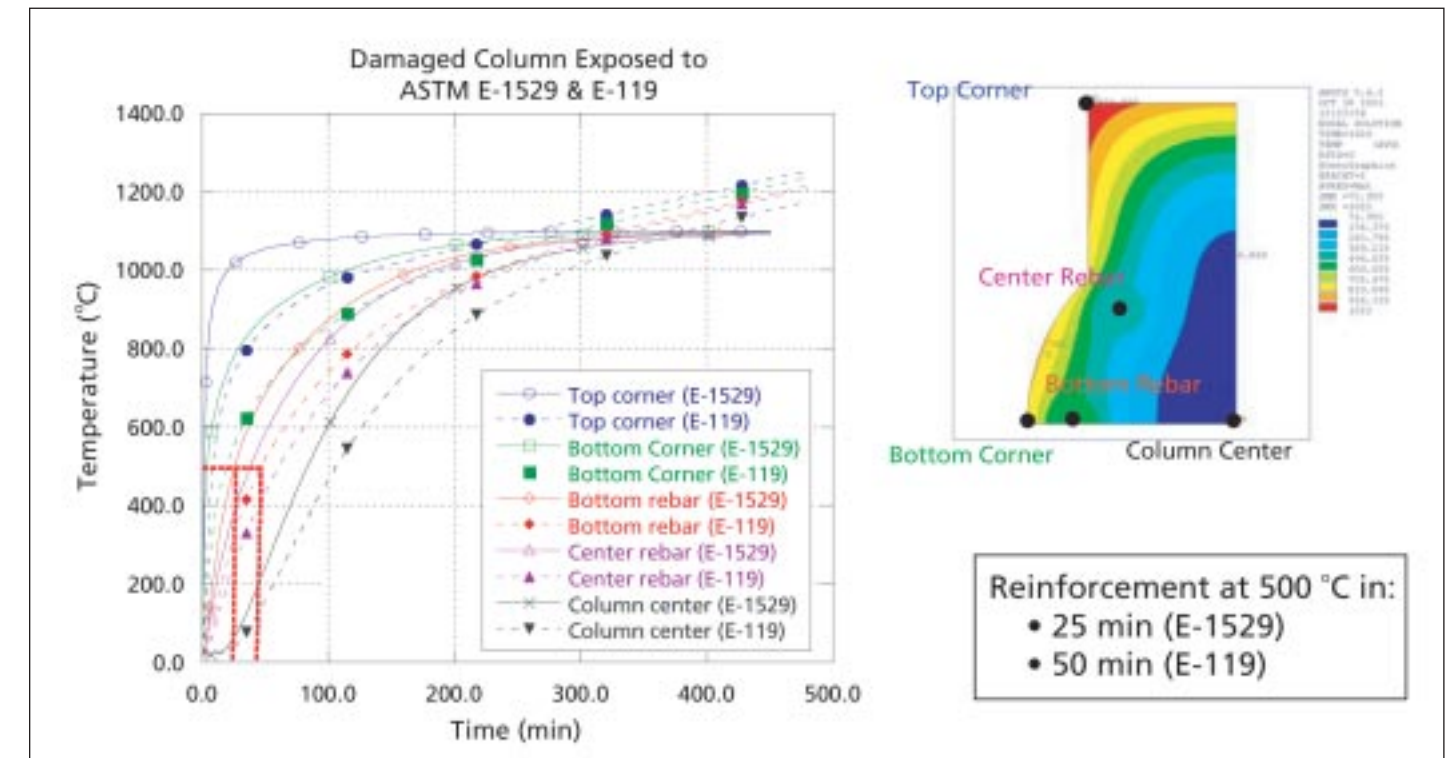
Figure 7.12 Temperature development in damaged column

and 120 minutes under the ISO 834 fire exposure. This represents the lower bound in fire endurance of the undamaged column and girder. However, once portions of the concrete cover for the reinforcement have been stripped off, the structural capacities of the damaged columns and girders can quickly be compromised, as reflected in the shortened fire endurance times obtained from the thermal analysis shown in figures 7.11 through 7.14 and listed in table 7.2. The fire endurance times for the column and beam are determined as the times for the main reinforcing steel to reach critical temperature (932°F [500°C], impending yielding temperature of steel reinforcement as defined in the Eurocode). For the column, the fire endurance time when damaged ranges from 25 minutes (based on the upper-bound fire ASTM E-1529) to 50 minutes (based on the lower-bound fire ASTM E-119). For the girder, the fire endurance time when damaged ranges from 12 minutes (ASTM E-1529) to 20 minutes (ASTM E-119). These endurance times compare well with the observed time to collapse after the initiation of the fire.

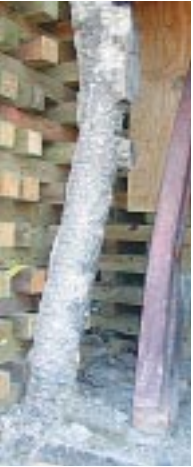
| COLUMN LABEL | DESCRIPTION OF DAMAGE | PHOTO (IF AVAILABLE) |
|---|---|---|
| 9AA | <ul style="list-style-type: none"><li>• Bowed</li><li>• Stripped to spiral reinforcement</li><li>• 5 to 6 inches out of plumb</li><li>• Shored</li></ul> | |

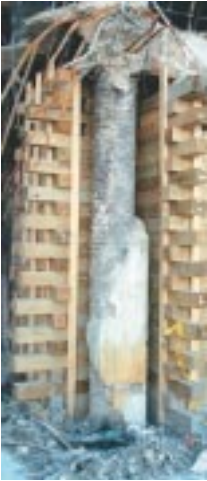
| COLUMN LABEL | DESCRIPTION OF DAMAGE | PHOTO (IF AVAILABLE) |
|---|---|---|
| 15B | <ul style="list-style-type: none"><li>• Spalled to spiral reinforcement from midheight to top</li><li>• Shored</li></ul> | |

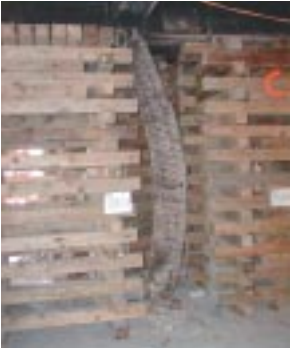
| COLUMN LABEL | DESCRIPTION OF DAMAGE | PHOTO (IF AVAILABLE) |
|---|---|---|
| 9C | <ul style="list-style-type: none"> <li>Severely bowed</li> <li>Stripped to spiral reinforcement</li> <li>Lost some concrete inside spiral reinforcement</li> <li>Shored</li> </ul> | |

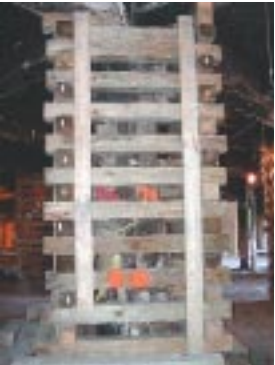
| COLUMN LABEL | DESCRIPTION OF DAMAGE | PHOTO (IF AVAILABLE) |
|---|---|---|
| 7D | <ul style="list-style-type: none"> <li>Split by vertical crack that looks typically like thermal cracking</li> <li>Shored</li> </ul> | |

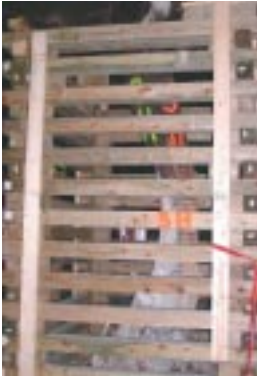
| COLUMN LABEL | DESCRIPTION OF DAMAGE | PHOTO (IF AVAILABLE) |
|---|---|---|
| 3H | <ul style="list-style-type: none"> <li>• Bowed</li> <li>• Stripped to spiral reinforcement at mid-height</li> <li>• Shored</li> </ul> | |

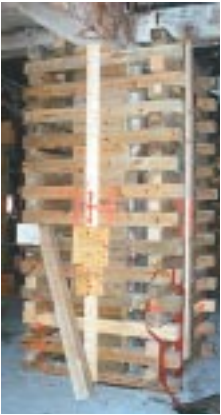
| COLUMN LABEL | DESCRIPTION OF DAMAGE | PHOTO (IF AVAILABLE) |
|---|---|---|
| 7H | <ul style="list-style-type: none"> <li>• Moderate spalling</li> <li>• Spalling more at top</li> <li>• No steel appears visible</li> <li>• Shored</li> </ul> | |

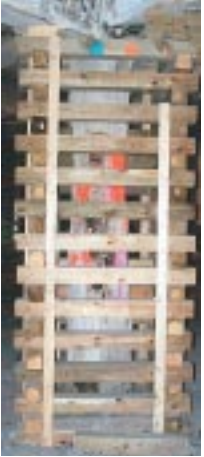
| COLUMN LABEL | DESCRIPTION OF DAMAGE | PHOTO (IF AVAILABLE) |
|---|---|---|
| 9H | <ul style="list-style-type: none"> <li>• Moderate spalling</li> <li>• Some spiral reinforcement visible</li> <li>• Vertical cracks</li> <li>• Shored</li> </ul> | |

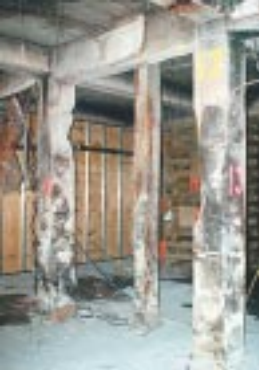
| COLUMN LABEL | DESCRIPTION OF DAMAGE | PHOTO (IF AVAILABLE) |
|---|---|---|
| 1J-North & 1J-South | <ul style="list-style-type: none"><li>• Intact</li><li>• Blackened</li></ul> | |
